Access Compliance Report Public Rights-of-Way (Curb Ramps)

Intersection ID: 20954Main Street:SHARON_VIEW_RDCross Street:SOUTH_HILL_VIEW_DRLocation:NEADA ID: 39EA4A77DAB4Ramp Type:PerpDiagInitial Pass/Fail:FailOverall Compliance:NoSeverity Score:33.75

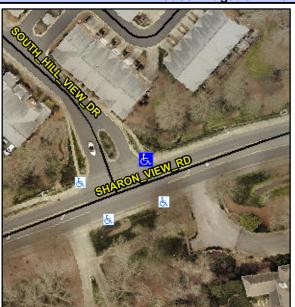
Compliance Description Data Compliance Description Data Yes Ramp Slope (%) N/A Ramp Length (in) 55.5 7.1 No Ramp XSlope (%) No Ramp Width (in) 41.0 9.6 N/A Flare Type LT N/A N/A Flare Type RT N/A N/A N/A Flare Slope RT (%) Flare Slope LT (%) N/A N/A N/A Flare Traversable LT? N/A N/A Flare Traversable RT? N/A N/A Landing Length (in) N/A N/A DWS Provided? N/A N/A Landing Width (in) N/A N/A **DWS Contrast?** N/A N/A N/A Landing Slope (%) N/A DWS Length (in) N/A N/A Landing X Slope (%) N/A N/A DWS Full Width? N/A N/A Landing Curb? (Y/N) N/A N/A DWS Offset (in) N/A N/A N/A Shared Landing? N/A **Gutter Ponding?** N/A N/A Gutter Slope (%) N/A N/A Gutter Lip Ht (in) N/A N/A Gutter X Slope (%) N/A N/A Painted X Walk1? No N/A Painted X Walk2? No X Walk 1 Direction To SW X Walk 2 Direction To S N/A N/A X Walk 1 Width (in) X Walk 2 Width (in) N/A X Walk 1 Slope (%) 0.3 X Walk 2 Slope (%) 15.0 X Walk 1 X Slope (%) 12.2 X Walk 2 X Slope (%) 0.3 N/A N/A N/A Ramp inside XWalk2? N/A Ramp inside XWalk1? Road Slope (%) 10.4 N/A Clear Space? N/A N/A Road X Slope (%) 10.9 Clear Space to XWalk (in) N/A N/A N/A Any Obstructions? N/A Storm Grate/Utility Hazard? N/A **Obstruction Type** Storm Grate/Utility Type N/A N/A Yes Surface Condition? (G/P) Good

Remove & Replace Curb Ramp With Two New Directional Ramps or Equivalent.
