Access Compliance Report

Public Rights-of-Way

(Curb Ramps)

Intersection ID: 15381	Main Street: BERKSHIRE_RD	Cross Street: OAKCREST_PL	Location: NW
ADA ID: 39F372B1B9E5	Ramp Type: PerpDiag	Initial Pass/Fail: Fail	Overall Compliance: No
Codes/Mitigation Info/Possible Solution		Field Measurements/Component Compliance	
Severity Score: 46.25

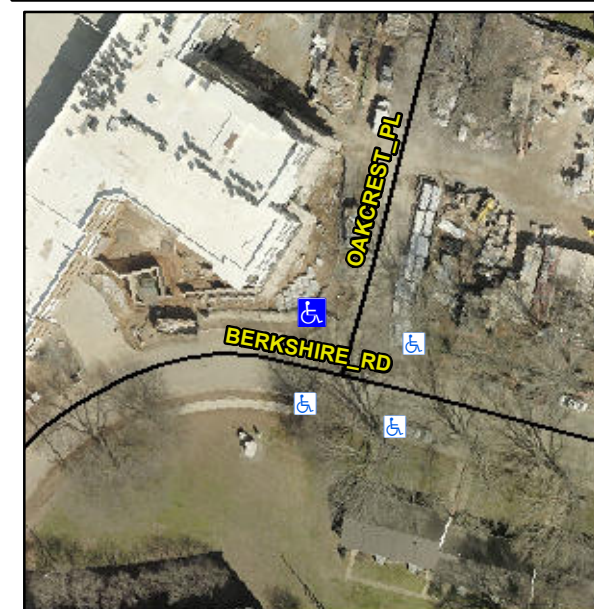
Not Found, R304.5.1, R304.2.2, R304.5.3

Compliance	Description	Data	Compliance	Description	Data
N/A	Ramp Length (in)	60.0	No	Ramp Slope (%)	9.8
No	Ramp Width (in)	42.0	No	Ramp XSlope (%)	9.9
N/A	Flare Type LT	N/A	N/A	Flare Type RT	N/A
N/A	Flare Slope LT (%)	N/A	N/A	Flare Slope RT (%)	N/A
N/A	Flare Traversable LT?	N/A	N/A	Flare Traversable RT?	N/A
N/A	Landing Length (in)	N/A	N/A	DWS Provided?	N/A
N/A	Landing Width (in)	N/A	N/A	DWS Contrast?	N/A
N/A	Landing Slope (%)	N/A	N/A	DWS Length (in)	N/A
N/A	Landing X Slope (%)	N/A	N/A	DWS Full Width?	N/A
N/A	Landing Curb? (Y/N)	N/A	N/A	DWS Offset (in)	N/A
N/A	Shared Landing?	N/A			
N/A	Gutter Ponding?	N/A	N/A	Gutter Slope (%)	N/A
N/A	Gutter Lip Ht (in)	N/A	N/A	Gutter X Slope (%)	N/A
N/A	Painted X Walk1?	No	N/A	Painted X Walk2?	No
	X Walk 1 Direction	To SW		X Walk 2 Direction	To SE
N/A	X Walk 1 Width (in)	N/A	N/A	X Walk 2 Width (in)	N/A
	X Walk 1 Slope (%)	5.2		X Walk 2 Slope (%)	1.7
	X Walk 1 X Slope (%)	3.5		X Walk 2 X Slope (%)	5.8

N/A	Ramp inside XWalk1?	N/A	N/A	Ramp inside XWalk2?	N/A
	Road Slope (%)	7.6	N/A	Clear Space?	N/A
	Road X Slope (%)	2.7	N/A	Clear Space to XWalk (in)	N/A
N/A	Any Obstructions?	N/A	N/A	Storm Grate/Utility Hazard?	N/A
	Obstruction Type			Storm Grate/Utility Type	
		N/A			N/A
			Yes	Surface Condition? (G/P)	Good

Remove & Replace Curb Ramp With Two New Directional Ramps or Equivalent.
