Access Compliance Report

Public Rights-of-Way

(Curb Ramps)

| Intersection ID: 31626 | Main Street: PLAZA_WALK_DR | Cross Street: THE_PLAZA | Location: SW |

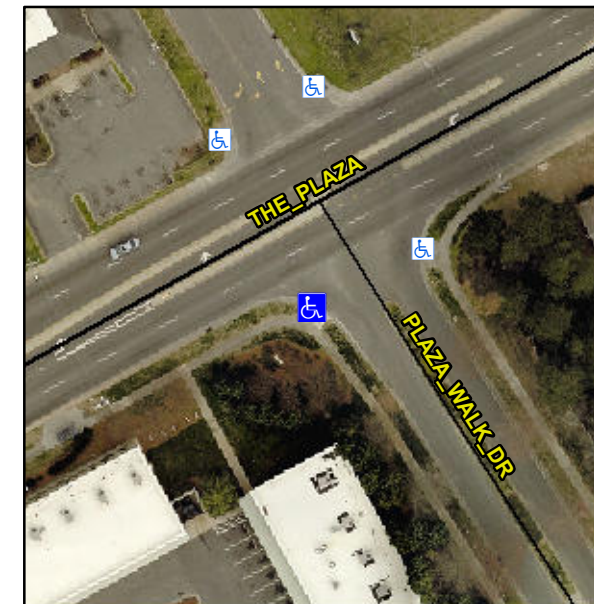
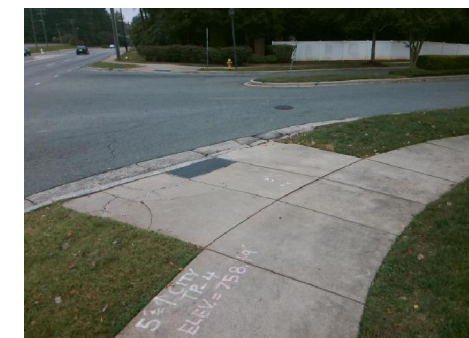
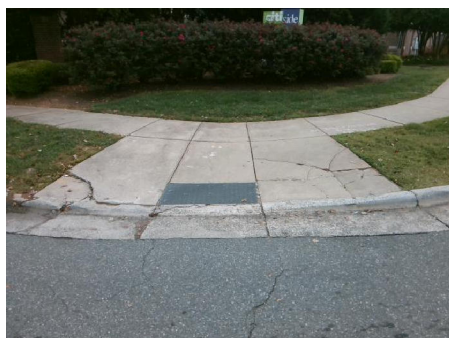
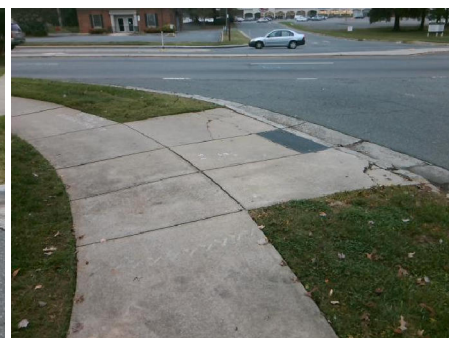
| ADA ID: 39FDEFE862C4 | Ramp Type: Perp | Initial Pass/Fail: Fail | Overall Compliance: No |

Not Found, R304.5.1, R304.5.3

| Compliance | Description | Data | Compliance | Description | Data |
|---|---|---|---|---|---|
| No | Ramp Width (in) | 42.5 | No | Ramp XSlope (%) | 3.5 |

Remove & Replace Entire Ramp.
