Access Compliance Report

Public Rights-of-Way

(Curb Ramps)

Intersection ID: 18310	Main Street: VICKSBURG_RD	Cross Street: BATHURST_DR	Location: SW
ADA ID: 3A01BEFEC966	Ramp Type: Perp	Initial Pass/Fail: Fail	Overall Compliance: No
Severity Score: 13.75			
Codes/Mitigation Info/Possible Solution		Field Measurements/Component Compliance

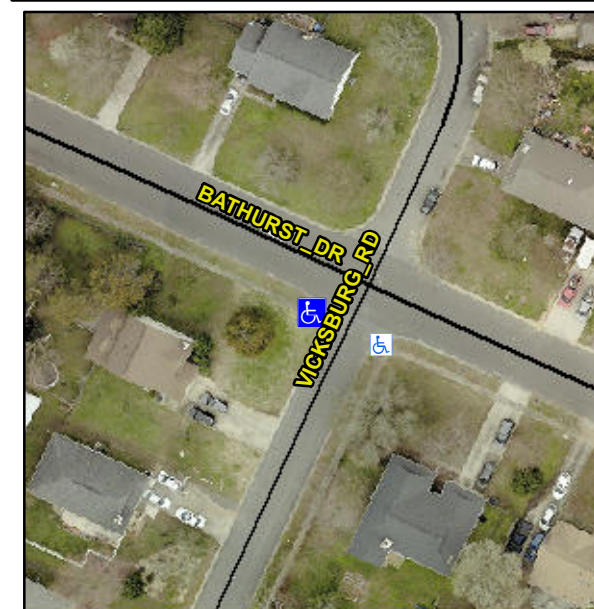
Not Found, R304.2.2, R304.5.3

Compliance	Description	Data	Compliance	Description	Data
N/A	Ramp Length (in)	51.0	No	Ramp Slope (%)	8.8
Yes	Ramp Width (in)	48.0	No	Ramp XSlope (%)	2.1
N/A	Flare Type LT	N/A	N/A	Flare Type RT	N/A
N/A	Flare Slope LT (%)	N/A	N/A	Flare Slope RT (%)	N/A
N/A	Flare Traversable LT?	N/A	N/A	Flare Traversable RT?	N/A
N/A	Landing Length (in)	N/A	N/A	DWS Provided?	N/A
N/A	Landing Width (in)	N/A	N/A	DWS Contrast?	N/A
N/A	Landing Slope (%)	N/A	N/A	DWS Length (in)	N/A
N/A	Landing X Slope (%)	N/A	N/A	DWS Full Width?	N/A
N/A	Landing Curb? (Y/N)	N/A	N/A	DWS Offset (in)	N/A
N/A	Shared Landing?	N/A			
N/A	Gutter Ponding?	N/A	N/A	Gutter Slope (%)	N/A
N/A	Gutter Lip Ht (in)	N/A	N/A	Gutter X Slope (%)	N/A
N/A	Painted X Walk1?	No	N/A	Painted X Walk2?	N/A
	X Walk 1 Direction	To SE		X Walk 2 Direction	N/A
N/A	X Walk 1 Width (in)	N/A	N/A	X Walk 2 Width (in)	N/A
	X Walk 1 Slope (%)	2.6		X Walk 2 Slope (%)	N/A
	X Walk 1 X Slope (%)	0.4		X Walk 2 X Slope (%)	N/A

N/A	Ramp inside XWalk1?	N/A	N/A	Ramp inside XWalk2?	N/A
	Road Slope (%)	N/A	N/A	Clear Space?	N/A
	Road X Slope (%)	N/A	N/A	Clear Space to XWalk (in)	N/A
N/A	Any Obstructions?	N/A	N/A	Storm Grate/Utility Hazard?	N/A
	Obstruction Type			Storm Grate/Utility Type	
		N/A			N/A
			Yes	Surface Condition? (G/P)	Good

Possible Solutions:

Remove & Replace Entire Ramp.
