## Access Compliance Report Public Rights-of-Way (Curb Ramps)

Intersection ID: 31735 Main Street: RAISIN\_TREE\_LN Cross Street: PAPER\_BIRCH\_DR Location: E

ADA ID: 3A05554D7AD1 Ramp Type: PerpDiag Initial Pass/Fail: Fail Overall Compliance: No Severity Score: 10

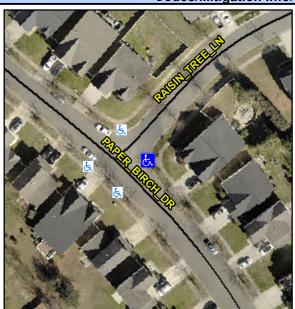
Not Found, R304.5.1, R304.5.3

r leid Measurements/Component Compilance						
	Compliance Description		Data	Compli	ance Description	Data
	N/A	Ramp Length (in)	84.0	Yes	Ramp Slope (%)	7.1
	No	Ramp Width (in)	37.0	No	Ramp XSlope (%)	4.0
	N/A	Flare Type LT	N/A	N/A	Flare Type RT	N/A
	N/A	Flare Slope LT (%)	N/A	N/A	Flare Slope RT (%)	N/A
	N/A	Flare Traversable LT?	N/A	N/A	Flare Traversable RT?	N/A
	N/A	Landing Length (in)	N/A	N/A	DWS Provided?	N/A
	N/A	Landing Width (in)	N/A	N/A	DWS Contrast?	N/A
	N/A	Landing Slope (%)	N/A	N/A	DWS Length (in)	N/A
	N/A	Landing X Slope (%)	N/A	N/A	DWS Full Width?	N/A
	N/A	Landing Curb? (Y/N)	N/A	N/A	DWS Offset (in)	N/A
	N/A	Shared Landing?	N/A			
	N/A	Gutter Ponding?	N/A	N/A	Gutter Slope (%)	N/A
	N/A	Gutter Lip Ht (in)	0.5	N/A	Gutter X Slope (%)	N/A
	N/A	Painted X Walk1?	No	N/A	Painted X Walk2?	No
		X Walk 1 Direction	To NW		X Walk 2 Direction	To SW
	N/A	X Walk 1 Width (in)	N/A	N/A	X Walk 2 Width (in)	N/A
		X Walk 1 Slope (%)	1.4		X Walk 2 Slope (%)	3.8

X Walk 1 X Slope (%)	3.9		X Walk 2 X Slope (%)	2.4
	N/A	Ramp inside XWalk1?	N/A	N/A	Ramp inside XWalk2?	N/A
		Road Slope (%)	1.7	N/A	Clear Space?	N/A
		Road X Slope (%)	2.9	N/A	Clear Space to XWalk (in)	N/A
	N/A	Any Obstructions?	N/A	N/A	Storm Grate/Utility Hazard?	N/A

Remove & Replace Curb Ramp With Two New Directional Ramps or Equivalent.

Total Cost: \$ 3200.00
