Access Compliance Report

Public Rights-of-Way

(Curb Ramps)

Intersection ID: N/A	Main Street: OUTLETS_BV	Cross Street: DESIGNER_DR	Location: SW
ADA ID: 3A1B68699939	Ramp Type: PerpDiag	Initial Pass/Fail: Fail	Overall Compliance: No
Severity Score: 1.25			
Codes/Mitigation Info/Possible Solution		Field Measurements/Component Compliance

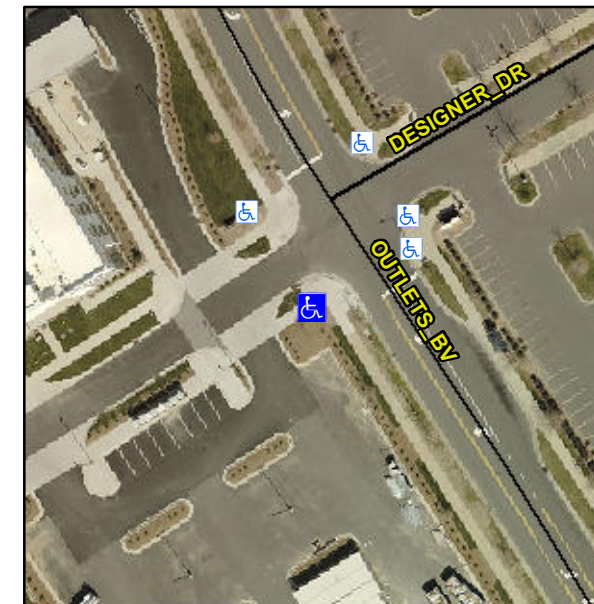
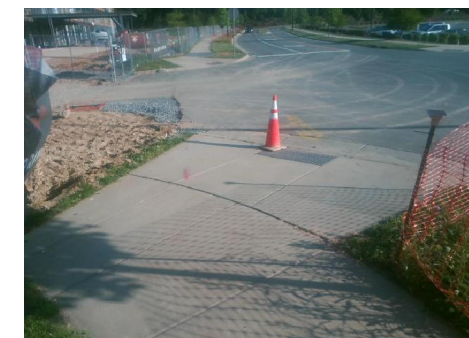
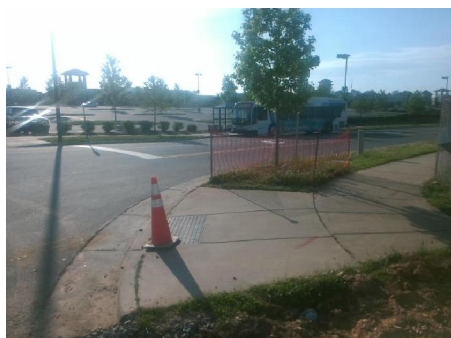
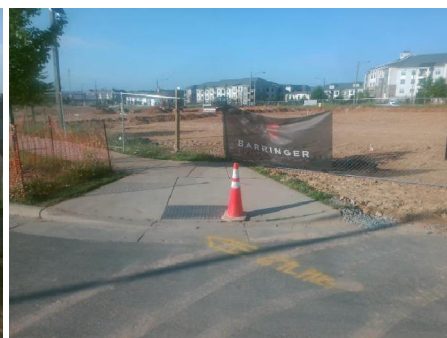
Compliance	Description	Data	Compliance	Description	Data
N/A	Ramp Length (in)	97.0	Yes	Ramp Slope (%)	6.1
Yes	Ramp Width (in)	48.0	No	Ramp XSlope (%)	2.7
N/A	Flare Type LT	N/A	N/A	Flare Type RT	N/A
N/A	Flare Slope LT (%)	N/A	N/A	Flare Slope RT (%)	N/A
N/A	Flare Traversable LT?	N/A	N/A	Flare Traversable RT?	N/A
N/A	Landing Length (in)	N/A	N/A	DWS Provided?	N/A
N/A	Landing Width (in)	N/A	N/A	DWS Contrast?	N/A
N/A	Landing Slope (%)	N/A	N/A	DWS Length (in)	N/A
N/A	Landing X Slope (%)	N/A	N/A	DWS Full Width?	N/A
N/A	Landing Curb? (Y/N)	N/A	N/A	DWS Offset (in)	N/A
N/A	Shared Landing?	N/A			
N/A	Gutter Ponding?	N/A	N/A	Gutter Slope (%)	N/A
N/A	Gutter Lip Ht (in)	N/A	N/A	Gutter X Slope (%)	N/A
N/A	Painted X Walk1?	No	N/A	Painted X Walk2?	No
	X Walk 1 Direction	To E		X Walk 2 Direction	To N
N/A	X Walk 1 Width (in)	N/A	N/A	X Walk 2 Width (in)	N/A
	X Walk 1 Slope (%)	4.7		X Walk 2 Slope (%)	2.4
	X Walk 1 X Slope (%)	2.9		X Walk 2 X Slope (%)	3.2

N/A	Ramp inside XWalk1?	N/A	N/A	Ramp inside XWalk2?	N/A
	Road Slope (%)	0.5	N/A	Clear Space?	N/A
	Road X Slope (%)	4.7	N/A	Clear Space to XWalk (in)	N/A
N/A	Any Obstructions?	N/A	N/A	Storm Grate/Utility Hazard?	N/A
	Obstruction Type			Storm Grate/Utility Type	
		N/A			N/A
		Yes		Surface Condition? (G/P)	Good

Possible Solutions:

Remove & Replace Curb Ramp With Two New Directional Ramps or Equivalent.
