## **Access Compliance Report Public Rights-of-Way** (Curb Ramps)

Intersection ID: 16407 Main Street: PORTLAND AV **Cross Street: PROVIDENCE\_RD** Location: NW ADA ID: 3A1E5009C64C Ramp Type: PerpDiag Initial Pass/Fail: Fail **Overall Compliance: No** Severity Score: 26.25

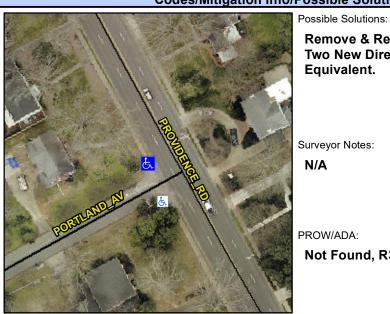
Comp	Compliance Description		Comp	liance Description	Data
N/A	Ramp Length (in)	32.0	No	Ramp Slope (%)	14.4
Yes	Ramp Width (in)	48.0	No	Ramp XSlope (%)	3.0
N/A	Flare Type LT	N/A	N/A	Flare Type RT	N/A
N/A	Flare Slope LT (%)	N/A	N/A	Flare Slope RT (%)	N/A
N/A	Flare Traversable LT?	N/A	N/A	Flare Traversable RT?	N/A
N/A	Landing Length (in)	N/A	N/A	DWS Provided?	N/A
N/A	Landing Width (in)	N/A	N/A	DWS Contrast?	N/A
N/A	Landing Slope (%)	N/A	N/A	DWS Length (in)	N/A
N/A	Landing X Slope (%)	N/A	N/A	DWS Full Width?	N/A
N/A	Landing Curb? (Y/N)	N/A	N/A	DWS Offset (in)	N/A
N/A	Shared Landing?	N/A			
N/A	Gutter Ponding?	N/A	N/A	Gutter Slope (%)	N/A
N/A	Gutter Lip Ht (in)	N/A	N/A	Gutter X Slope (%)	N/A
N/A	Painted X Walk1?	No	N/A	Painted X Walk2?	No
	X Walk 1 Direction	To SE		X Walk 2 Direction	To NE
N/A	X Walk 1 Width (in)	N/A	N/A	X Walk 2 Width (in)	N/A
	X Walk 1 Slope (%)	0.3		X Walk 2 Slope (%)	1.4
	X Walk 1 X Slope (%)	1.3		X Walk 2 X Slope (%)	0.9

N/A	Ramp inside XWalk1?	N/A	N/A	Ramp inside XWalk2?	N/A
	Road Slope (%)	0.3	N/A	Clear Space?	N/A
	Road X Slope (%)	0.7	N/A	Clear Space to XWalk (in)	N/A
N/A	Any Obstructions?	N/A	N/A	Storm Grate/Utility Hazard?	N/A
	Obstruction Type			Storm Grate/Utility Type	
		N/A			N/A
			I

Remove & Replace Curb Ramp With Two New Directional Ramps or Equivalent.

一個の一個のでは、1000年の大学の大学の大学の大学の大学の大学の大学の大学の大学の大学の大学の大学の大学の	PROW/ADA:  Not Found, R304.2.2, R304.	
	Total Cost:	•

3200.00
