# Access Compliance Report

## Public Rights-of-Way

| Intersection ID: 45511 | Main Street: MEADOW_BOTTOM_RD | Cross Street: GINHOUSE_LN | Location: | W |
| ADA ID: 3A21779B409F | Ramp Type: PerpDiag | Initial Pass/Fail: Fail | Overall Compliance: No | Severity Score: 22.5 |

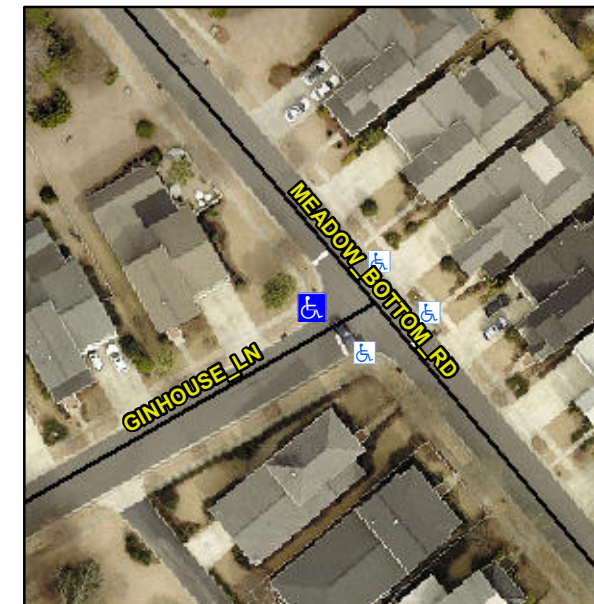
**R304.5.1, R304.2.2, R304.5.3**

| Compliance | Description | Data | Compliance | Description | Data |
|---|---|---|---|---|---|
| N/A | Ramp Length (in) | 73.0 | No | Ramp Slope (%) | 9.6 |
| No | Ramp Width (in) | 46.0 | No | Ramp XSlope (%) | 2.3 |

**Remove & Replace Curb Ramp With Two New Directional Ramps or Equivalent.**

Total Cost: \$ 3200.00
