Access Compliance Report

Public Rights-of-Way

(Curb Ramps)

| Intersection ID: 6255 | Main Street: HOOVER_DR | Cross Street: NEVIN_RD | Location: SW |

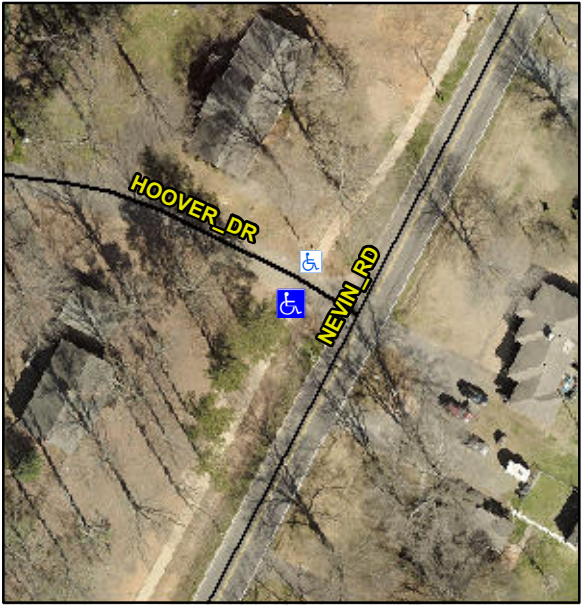
| ADA ID: 3A254D220E79 | Ramp Type: Perp | Initial Pass/Fail: Fail | Overall Compliance: No |
| | | Severity Score: 1.25 | |

| Codes/Mitigation Info/Possible Solution | | | Field Measurements/Component Compliance | | |
|--|--|--|---|---|---|
| <p>Surveyor Notes:</p> <p>N/A</p> <p>PROW/ADA:</p> <p>R304.5.3</p> | | | N/A | DWS Contrast? | N/A |

| Codes/Mitigation Info/Possible Solution | | | Field Measurements/Component Compliance | | |
|--|--|--|---|---|---|
| | Remove & Replace Entire Ramp. | | Yes | Ramp Length (in) | 73.0 |
