Access Compliance Report

Public Rights-of-Way

(Curb Ramps)

Intersection ID: 16545	Main Street: N_SHARON_AMITY_RD	Cross Street: MONROE_RD	Location: NW
ADA ID: 3A2A23120E9F	Ramp Type: Perp	Initial Pass/Fail: Fail	Overall Compliance: No
Severity Score: 8.75			
Codes/Mitigation Info/Possible Solution		Field Measurements/Component Compliance

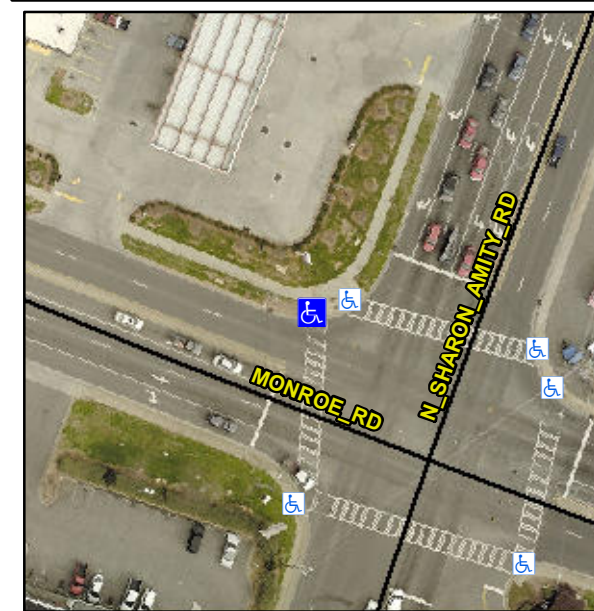
Not Found, R304.5.1

Compliance	Description	Data	Compliance	Description	Data
N/A	Ramp Length (in)	60.0	Yes	Ramp Slope (%)	5.2
No	Ramp Width (in)	42.0	Yes	Ramp XSlope (%)	0.2
N/A	Flare Type LT	N/A	N/A	Flare Type RT	N/A
N/A	Flare Slope LT (%)	N/A	N/A	Flare Slope RT (%)	N/A
N/A	Flare Traversable LT?	N/A	N/A	Flare Traversable RT?	N/A
N/A	Landing Length (in)	N/A	N/A	DWS Provided?	N/A
N/A	Landing Width (in)	N/A	N/A	DWS Contrast?	N/A
N/A	Landing Slope (%)	N/A	N/A	DWS Length (in)	N/A
N/A	Landing X Slope (%)	N/A	N/A	DWS Full Width?	N/A
N/A	Landing Curb? (Y/N)	N/A	N/A	DWS Offset (in)	N/A
N/A	Shared Landing?	N/A			
N/A	Gutter Ponding?	N/A	N/A	Gutter Slope (%)	N/A
N/A	Gutter Lip Ht (in)	N/A	N/A	Gutter X Slope (%)	N/A
N/A	Painted X Walk1?	Yes	N/A	Painted X Walk2?	N/A
	X Walk 1 Direction	To SW		X Walk 2 Direction	N/A
N/A	X Walk 1 Width (in)	101.0	N/A	X Walk 2 Width (in)	N/A
	X Walk 1 Slope (%)	2.6		X Walk 2 Slope (%)	N/A
	X Walk 1 X Slope (%)	2.0		X Walk 2 X Slope (%)	N/A

N/A	Ramp inside XWalk1?	Yes	N/A	Ramp inside XWalk2?	N/A
	Road Slope (%)	N/A	N/A	Clear Space?	N/A
	Road X Slope (%)	N/A	N/A	Clear Space to XWalk (in)	N/A
N/A	Any Obstructions?	N/A	N/A	Storm Grate/Utility Hazard?	N/A
	Obstruction Type			Storm Grate/Utility Type	
		N/A			N/A
		Yes		Surface Condition? (G/P)	Good

Possible Solutions:

Remove & Replace Entire Ramp.
