Access Compliance Report

Public Rights-of-Way

(Curb Ramps)

Intersection ID: 2827	Main Street: DERVISH_LN	Cross Street: SWALLOW_TAIL_LN	Location: S
ADA ID: 3A2BCD1578DF	Ramp Type: PerpDiag	Initial Pass/Fail: Fail	Overall Compliance: No
			Severity Score: 21.25

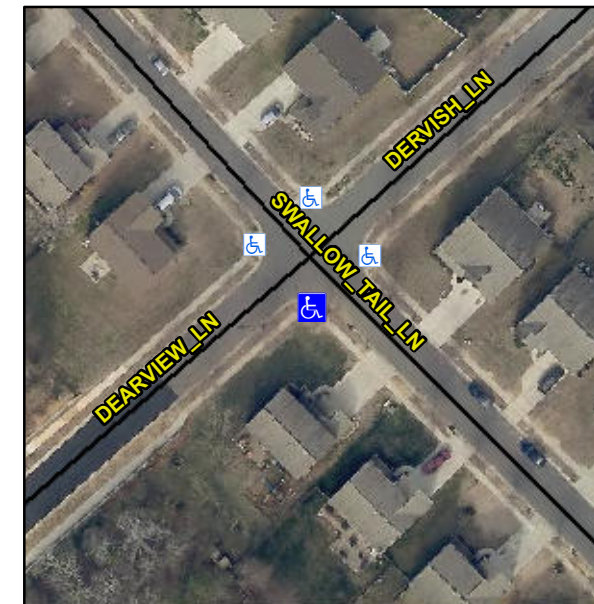
Not Found, R304.5.1, R304.5.3

Compliance	Description	Data	Compliance	Description	Data
N/A	Ramp Length (in)	48.0	Yes	Ramp Slope (%)	6.4
No	Ramp Width (in)	36.0	No	Ramp XSlope (%)	5.3
N/A	Flare Type LT	N/A	N/A	Flare Type RT	N/A
N/A	Flare Slope LT (%)	N/A	N/A	Flare Slope RT (%)	N/A
N/A	Flare Traversable LT?	N/A	N/A	Flare Traversable RT?	N/A
N/A	Landing Length (in)	N/A	N/A	DWS Provided?	N/A
N/A	Landing Width (in)	N/A	N/A	DWS Contrast?	N/A
N/A	Landing Slope (%)	N/A	N/A	DWS Length (in)	N/A
N/A	Landing X Slope (%)	N/A	N/A	DWS Full Width?	N/A
N/A	Landing Curb? (Y/N)	N/A	N/A	DWS Offset (in)	N/A
N/A	Shared Landing?	N/A			
N/A	Gutter Ponding?	N/A	N/A	Gutter Slope (%)	N/A
N/A	Gutter Lip Ht (in)	N/A	N/A	Gutter X Slope (%)	N/A
N/A	Painted X Walk1?	No	N/A	Painted X Walk2?	No
	X Walk 1 Direction	To NE		X Walk 2 Direction	To NW
N/A	X Walk 1 Width (in)	N/A	N/A	X Walk 2 Width (in)	N/A
	X Walk 1 Slope (%)	0.7		X Walk 2 Slope (%)	1.8
	X Walk 1 X Slope (%)	1.9		X Walk 2 X Slope (%)	2.6

N/A	Ramp inside XWalk1?	N/A	N/A	Ramp inside XWalk2?	N/A
	Road Slope (%)	2.9	N/A	Clear Space?	N/A
	Road X Slope (%)	1.3	N/A	Clear Space to XWalk (in)	N/A
N/A	Any Obstructions?	N/A	N/A	Storm Grate/Utility Hazard?	N/A
	Obstruction Type			Storm Grate/Utility Type	
		N/A			N/A
			Yes	Surface Condition? (G/P)	Good

Remove & Replace Curb Ramp With Two New Directional Ramps or Equivalent.
