Access Compliance Report

Public Rights-of-Way

(Curb Ramps)

Intersection ID: 10735	Main Street: N_DAVIDSON_ST	Cross Street: E_27TH_ST	Location: SE
ADA ID: 3A2F16242968	Ramp Type: Perp	Initial Pass/Fail: Fail	Overall Compliance: No
Severity Score: 10			
Codes/Mitigation Info/Possible Solution		Field Measurements/Component Compliance

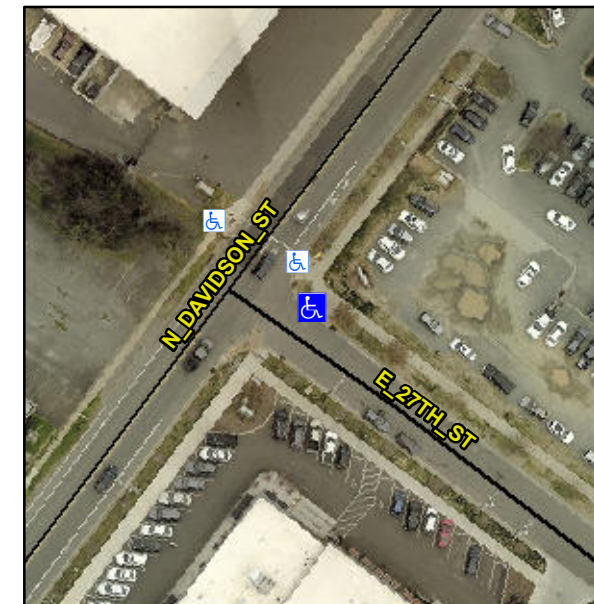
Not Found, R304.5.1, R304.5.3

Compliance	Description	Data	Compliance	Description	Data
N/A	Ramp Length (in)	99.0	Yes	Ramp Slope (%)	5.0
No	Ramp Width (in)	47.5	No	Ramp XSlope (%)	3.5
N/A	Flare Type LT	N/A	N/A	Flare Type RT	N/A
N/A	Flare Slope LT (%)	N/A	N/A	Flare Slope RT (%)	N/A
N/A	Flare Traversable LT?	N/A	N/A	Flare Traversable RT?	N/A
N/A	Landing Length (in)	N/A	N/A	DWS Provided?	N/A
N/A	Landing Width (in)	N/A	N/A	DWS Contrast?	N/A
N/A	Landing Slope (%)	N/A	N/A	DWS Length (in)	N/A
N/A	Landing X Slope (%)	N/A	N/A	DWS Full Width?	N/A
N/A	Landing Curb? (Y/N)	N/A	N/A	DWS Offset (in)	N/A
N/A	Shared Landing?	N/A			
N/A	Gutter Ponding?	N/A	N/A	Gutter Slope (%)	N/A
N/A	Gutter Lip Ht (in)	N/A	N/A	Gutter X Slope (%)	N/A
N/A	Painted X Walk1?	No	N/A	Painted X Walk2?	N/A
	X Walk 1 Direction	To SW		X Walk 2 Direction	N/A
N/A	X Walk 1 Width (in)	N/A	N/A	X Walk 2 Width (in)	N/A
	X Walk 1 Slope (%)	1.5		X Walk 2 Slope (%)	N/A
	X Walk 1 X Slope (%)	2.7		X Walk 2 X Slope (%)	N/A

N/A	Ramp inside XWalk1?	N/A	N/A	Ramp inside XWalk2?	N/A
	Road Slope (%)	N/A	N/A	Clear Space?	N/A
	Road X Slope (%)	N/A	N/A	Clear Space to XWalk (in)	N/A
N/A	Any Obstructions?	N/A	N/A	Storm Grate/Utility Hazard?	N/A
	Obstruction Type			Storm Grate/Utility Type	
		N/A			N/A
			Yes	Surface Condition? (G/P)	Good

Possible Solutions:

Remove & Replace Entire Ramp.

Total Cost: \$ 1850.00
