## Access Compliance Report Public Rights-of-Way (Curb Ramps)

Intersection ID: 50272Main Street:SOUTH\_BVCross Street:WHITTON\_STLocation:SWADA ID: 3A3A527370E3Ramp Type:PerpInitial Pass/Fail:FailOverall Compliance:NoSeverity Score:13.75

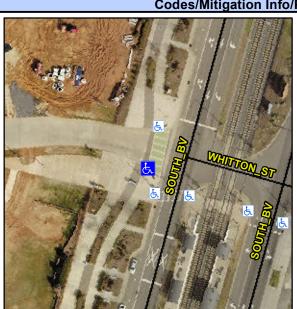
Possible Solution			Field Measurements/Component Compliance				
Possible Solutions:			Comp	liance Description	Data	Compliance Description	
Remove & Replace Entire	Ram	ıp.	N/A	Ramp Length (in)	72.0	No Ramp Slope (%)

•		•	Yes	Ramp Width (in)	120.0	No Ramp XSlope (%)	
			N/A	Flare Type LT	N/A	N/A Flare Type RT	
			N/A	Flare Slope LT (%)	N/A	N/A Flare Slope RT (%)	
			N/A	Flare Traversable LT?	N/A	N/A Flare Traversable RT?	
			N/A	Landing Length (in)	N/A	N/A DWS Provided?	
Surveyor Notes:			N/A	Landing Width (in)	N/A	N/A DWS Contrast?	
N/A			N/A	Landing Slope (%)	N/A	N/A DWS Length (in)	
			N/A	Landing X Slope (%)	N/A	N/A DWS Full Width?	
			N/A	Landing Curb? (Y/N)	N/A	N/A DWS Offset (in)	
			N/A	Shared Landing?	N/A		
PROW/ADA:			N/A	Gutter Ponding?	N/A	N/A Gutter Slope (%)	
Not Found, R304.2.2, R304.5.3			N/A	Gutter Lip Ht (in)	N/A	N/A Gutter X Slope (%)	
			N/A	Painted X Walk1?	Yes	N/A Painted X Walk2?	
				X Walk 1 Direction	To NE	X Walk 2 Direction	
			N/A	X Walk 1 Width (in)	162.0	N/A X Walk 2 Width (in)	
				X Walk 1 Slope (%)	3.8	X Walk 2 Slope (%)	
				X Walk 1 X Slope (%)	1.4	X Walk 2 X Slope (%)	
			N/A	Ramp inside XWalk1?	Yes	N/A Ramp inside XWalk2?
