## Access Compliance Report Public Rights-of-Way (Curb Ramps)

Intersection ID: 14971 Main Street: PIERCE\_ST Cross Street: SCOTT\_AV Location: N

ADA ID: 3A3EE6D83DC2 Ramp Type: Directional1 Initial Pass/Fail: Fail Overall Compliance: No Severity Score: 1.25

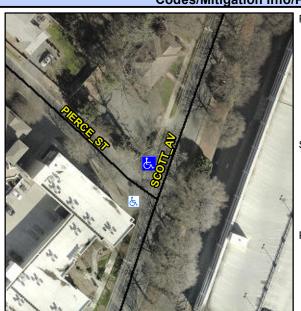
R304.5.3

Compliance Description Data Compliance Description Data 38.0 N/A N/A Ramp Length (in) Grade Break? N/A 50.0 N/A Yes Ramp Width (in) Grade Break Slope (%) 0.0 N/A Yes Ramp Slope (%) 5.2 Grade Break XSlope (%) 0.0 No Ramp XSlope (%) 4.1 N/A Flare Type LT N/A N/A Flare Type RT N/A N/A Flare Slope LT (%) N/A N/A Flare Slope RT (%) 0.0 N/A Flare Traversable LT? N/A N/A Flare Traversable RT? N/A N/A 0.0 N/A **DWS Provided?** Landing Length (in) N/A N/A Landing Width (in) 0.0 N/A **DWS Contrast?** N/A N/A Landing Slope (%) 0.0 N/A DWS Length (in) N/A N/A N/A Landing X Slope (%) 0.0 DWS Full Width? N/A N/A Landing Curb? (Y/N) N/A N/A DWS Offset LT (in) N/A N/A Shared Landing? N/A N/A DWS Offset RT (in) N/A N/A **Gutter Ponding?** 0.0 N/A Gutter Slope (%) N/A N/A Gutter Lip Ht (in) 0.0 N/A Gutter X Slope (%) N/A N/A Painted X Walk1? No Road Slope (%) 10.7 To S X Walk 1 Direction Road X Slope (%) 0.2 X Walk 1 Width (in) N/A Clear Space? N/A 10.7 N/A N/A X Walk 1 Slope (%) Clear Space to XWalk (in) X Walk 1 X Slope (%) 0.2 N/A Storm Grate/Utility Hazard? N/A N/A Ramp inside XWalk1? N/A Storm Grate/Utility Type N/A N/A Any Obstructions? N/A **Obstruction Type** Surface Condition? (G/P) Yes Good N/A N/A Curb Slope (%) 4.7

Remove & Replace Entire Ramp.
