Access Compliance Report Public Rights-of-Way (Curb Ramps)

Intersection ID: 52627 Main Street: PICASSO_TERRACE_LN Cross Street: CORMWELL_LN Location: W

ADA ID: 3A3F2BDA0EC4 Ramp Type: Perp Initial Pass/Fail: Fail Overall Compliance: No Severity Score: 12.5

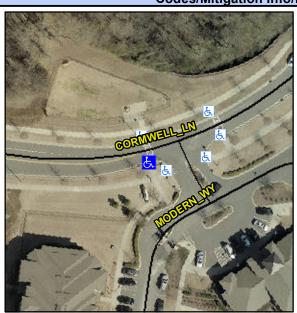
/Possible Solution	
Possible Solutions:	Co
Remove & Replace Entire Ramp.	N/A
·	Yes
	N/A
	N/A
	N/A
	N/A
Surveyor Notes:	N/A
N/A	N/A
	N/A
	N/A
	N/A
PROW/ADA:	N/A
Not Found, R304.2.2	N/A
	N/A
	N/A
	N/A
