## Access Compliance Report Public Rights-of-Way (Curb Ramps)

Intersection ID: 12299 Main Street: W\_MOREHEAD\_ST Cross Street: S\_CHASE\_ST Location: S

ADA ID: 3A581CEB271F Ramp Type: PerpDiag Initial Pass/Fail: Fail Overall Compliance: No Severity Score: 26.25

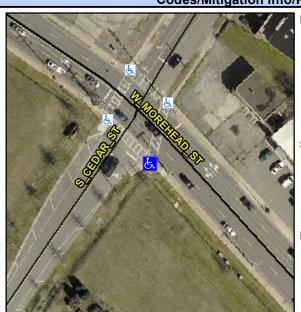
Not Found, R304.2.2, R304.5.3

Comp	liance Description	Data	Comp	liance	Description	Data
N/A	Ramp Length (in)	90.0	No	Ram	Slope (%)	12.8
Yes	Ramp Width (in)	60.0	No	Ram	XSlope (%)	4.1
N/A	Flare Type LT	N/A	N/A	Flare	Type RT	N/A
N/A	Flare Slope LT (%)	N/A	N/A	Flare	Slope RT (%)	N/A
N/A	Flare Traversable LT?	N/A	N/A	Flare	Traversable RT?	N/A
N/A	Landing Length (in)	N/A	N/A	DWS	Provided?	N/A
N/A	Landing Width (in)	N/A	N/A	DWS	Contrast?	N/A
N/A	Landing Slope (%)	N/A	N/A	DWS	Length (in)	N/A
N/A	Landing X Slope (%)	N/A	N/A	DWS	Full Width?	N/A
N/A	Landing Curb? (Y/N)	N/A	N/A	DWS	Offset (in)	N/A
N/A	Shared Landing?	N/A				
N/A	Gutter Ponding?	N/A	N/A	Gutte	er Slope (%)	N/A
N/A	Gutter Lip Ht (in)	N/A	N/A	Gutte	er X Slope (%)	N/A
N/A	Painted X Walk1?	Yes	N/A	Paint	ed X Walk2?	Yes
	X Walk 1 Direction	To NE		X Wa	lk 2 Direction	To NW
N/A	X Walk 1 Width (in)	117.0	N/A	X Wa	lk 2 Width (in)	108.0
	X Walk 1 Slope (%)	2.4		X Wa	lk 2 Slope (%)	2.4
	X Walk 1 X Slope (%)	1.3		X Wa	lk 2 X Slope (%)	0.8

N/A	Ramp inside XWalk1?	Yes	N/A	Ram	inside XWalk2?	Yes
	Road Slope (%)	2.5	N/A	Clea	Space?	N/A
	Road X Slope (%)	1.0	N/A	Clear	Space to XWalk (in)	N/A
N/A	Any Obstructions?	N/A	N/A	Storn	n Grate/Utility Hazard?	N/A
	Obstruction Type		l	Storn	n Grate/Utility Type	
		N/A	l			N/A

Remove & Replace Curb Ramp With
Two New Directional Ramps or
Equivalent.

Total Cost: \$ 3200.00
