Access Compliance Report Public Rights-of-Way (Curb Ramps)

Intersection ID: 16873 Main Street: HARTNESS AV Cross Street: WATER_OAK_RD Location: SW ADA ID: 3A58474951CF Ramp Type: Directional2 Initial Pass/Fail: Fail **Overall Compliance: No Severity Score:** 22.5

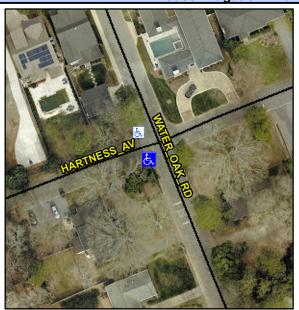
N/A	Ramp Length (in)	51.5	N/A	Grade Break?	N/A
No	Ramp Width (in)	38.5	N/A	Grade Break Slope (%)	0.0
No	Ramp Slope (%)	8.7	N/A	Grade Break XSlope (%)	0.0
No	Ramp XSlope (%)	3.2			
N/A	Flare Type LT	N/A	N/A	Flare Type RT	N/A
N/A	Flare Slope LT (%)	N/A	N/A	Flare Slope RT (%)	0.0
N/A	Flare Traversable LT?	N/A	N/A	Flare Traversable RT?	N/A
N/A	Landing Length (in)	0.0	N/A	DWS Provided?	N/A
N/A	Landing Width (in)	0.0	N/A	DWS Contrast?	N/A
N/A	Landing Slope (%)	0.0	N/A	DWS Length (in)	N/A
N/A	Landing X Slope (%)	0.0	N/A	DWS Full Width?	N/A
N/A	Landing Curb? (Y/N)	N/A	N/A	DWS Offset LT (in)	N/A
N/A	Shared Landing?	N/A	N/A	DWS Offset RT (in)	N/A
N/A	Gutter Ponding?	0.0	N/A	Gutter Slope (%)	N/A
N/A	Gutter Lip Ht (in)	0.0	N/A	Gutter X Slope (%)	N/A
N/A	Painted X Walk1?	No		Road Slope (%)	1.8
	X Walk 1 Direction	To NW		Road X Slope (%)	2.2
	X Walk 1 Width (in)	N/A		Clear Space?	N/A
	X Walk 1 Slope (%)	1.8	N/A	Clear Space to XWalk (in)	N/A

X Walk 1 X Slope (%)	2.2	N/A	Storm Grate/Utility Hazard?	N/A
N/A	Ramp inside XWalk1?	N/A		Storm Grate/Utility Type	
N/A	Any Obstructions?	N/A			N/A
	Obstruction Type		Yes	Surface Condition? (G/P)	Good
		N/A	N/A	Curb Slope (%)	0.5

HARTNESS AV Street 1 Name Stop Condition-Street 1 StopSign Street 2 Name N/A Stop Condition-Street 2 N/A Possible Solutions: Compliance Description Remove & Replace Entire Ramp. Surveyor Notes:

N/A			N/A
			N/A
			N/A
			N/A
PROW/ADA:			N/A
R304.5.1, R304.2.2, R304.	5.3		N/A
,			N/A
			N/A
			N/A
			N/A
Total Cost:	\$	1800.00
