Access Compliance Report

Public Rights-of-Way

(Curb Ramps)

Intersection ID: 11551	Main Street: E_16TH_ST	Cross Street: N_CALDWELL_ST	Location: N
ADA ID: 3A5F6DE66A68	Ramp Type: PerpDiag	Initial Pass/Fail: Fail	Overall Compliance: No
Severity Score: 25			
Codes/Mitigation Info/Possible Solution		Field Measurements/Component Compliance

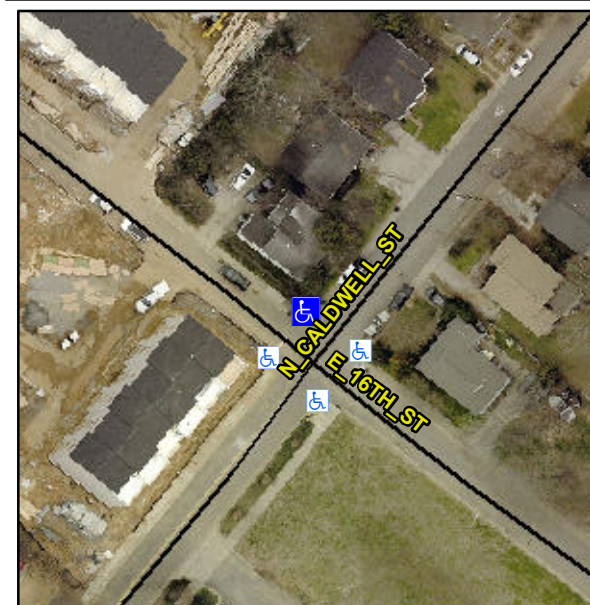
Not Found, R304.2.2

Compliance	Description	Data	Compliance	Description	Data
N/A	Ramp Length (in)	54.0	No	Ramp Slope (%)	12.7
Yes	Ramp Width (in)	48.0	Yes	Ramp XSlope (%)	1.5
N/A	Flare Type LT	N/A	N/A	Flare Type RT	N/A
N/A	Flare Slope LT (%)	N/A	N/A	Flare Slope RT (%)	N/A
N/A	Flare Traversable LT?	N/A	N/A	Flare Traversable RT?	N/A
N/A	Landing Length (in)	N/A	N/A	DWS Provided?	N/A
N/A	Landing Width (in)	N/A	N/A	DWS Contrast?	N/A
N/A	Landing Slope (%)	N/A	N/A	DWS Length (in)	N/A
N/A	Landing X Slope (%)	N/A	N/A	DWS Full Width?	N/A
N/A	Landing Curb? (Y/N)	N/A	N/A	DWS Offset (in)	N/A
N/A	Shared Landing?	N/A			
N/A	Gutter Ponding?	N/A	N/A	Gutter Slope (%)	N/A
N/A	Gutter Lip Ht (in)	N/A	N/A	Gutter X Slope (%)	N/A
N/A	Painted X Walk1?	No	N/A	Painted X Walk2?	No
	X Walk 1 Direction	To SW		X Walk 2 Direction	To SE
N/A	X Walk 1 Width (in)	N/A	N/A	X Walk 2 Width (in)	N/A
	X Walk 1 Slope (%)	0.6		X Walk 2 Slope (%)	2.0
	X Walk 1 X Slope (%)	1.1		X Walk 2 X Slope (%)	0.3

N/A	Ramp inside XWalk1?	N/A	N/A	Ramp inside XWalk2?	N/A
	Road Slope (%)	1.8	N/A	Clear Space?	N/A
	Road X Slope (%)	1.3	N/A	Clear Space to XWalk (in)	N/A
N/A	Any Obstructions?	N/A	N/A	Storm Grate/Utility Hazard?	N/A
	Obstruction Type			Storm Grate/Utility Type	
		N/A			N/A
		Yes		Surface Condition? (G/P)	Good

Possible Solutions:

Remove & Replace Curb Ramp With Two New Directional Ramps or Equivalent.

Total Cost: \$ **3200.00**
