## Access Compliance Report Public Rights-of-Way (Curb Ramps)

Intersection ID: 7346	Main Street: MOORES_CHAPEL_RD				Street:	OLD_LITTLE_ROCK_	Location:	N		
ADA ID: 3A66753700A4	Ramp Ty	amp Type: Perp			Initial Pass/Fail: Fail Overall Compliance			nce: N	o Severity Score:	46.25
Codes/Mitigation Info/Possible Solution			Field Measurements/Component Compliance							
	15 40	Possible Solutions:			Comp	ance Description Data Complian		liance Description	Data	
28 8 16.34		Remove & Replace Er	ntire Ramp.		N/A	Ramp Length (in)	60.0	No	Ramp Slope (%)	8.5

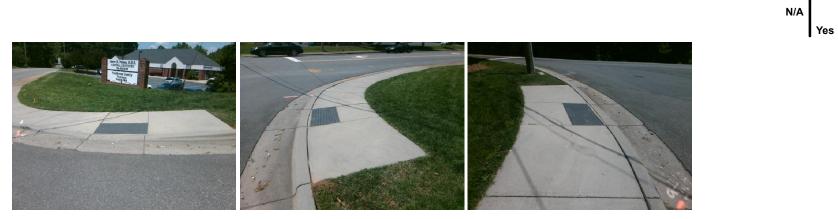
•		No	Ramp Width (in)	46.5	No	Ramp XSlope (%)	10.8
	a sheet				N/A	Flare Type LT	N/A	N/A	Flare Type RT	N/A
	int the				N/A	Flare Slope LT (%)	N/A	N/A	Flare Slope RT (%)	N/A
THE THE THE					N/A	Flare Traversable LT?	N/A	N/A	Flare Traversable RT?	N/A
					N/A	Landing Length (in)	N/A	N/A	DWS Provided?	N/A
		Surveyor Notes:			N/A	Landing Width (in)	N/A	N/A	DWS Contrast?	N/A
