# Access Compliance Report

## Public Rights-of-Way

### (Curb Ramps)

Intersection ID: 11311	Main Street: MILTON_RD	Cross Street: N_SHARON_AMITY_RD	Location: SE
ADA ID: 3A7C7CA65F30	Ramp Type: PerpDiag	Initial Pass/Fail: Fail	Overall Compliance: No
			Severity Score: 21.25

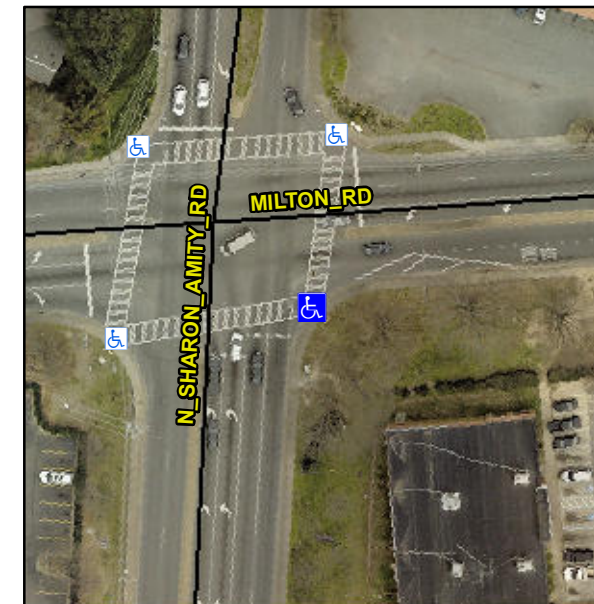
**Not Found, R304.5.1, R304.2.2**

Compliance	Description	Data	Compliance	Description	Data
N/A	Ramp Length (in)	59.0	No	Ramp Slope (%)	10.2
No	Ramp Width (in)	36.5	Yes	Ramp XSlope (%)	0.9
N/A	Flare Type LT	N/A	N/A	Flare Type RT	N/A
N/A	Flare Slope LT (%)	N/A	N/A	Flare Slope RT (%)	N/A
N/A	Flare Traversable LT?	N/A	N/A	Flare Traversable RT?	N/A
N/A	Landing Length (in)	N/A	N/A	DWS Provided?	N/A
N/A	Landing Width (in)	N/A	N/A	DWS Contrast?	N/A
N/A	Landing Slope (%)	N/A	N/A	DWS Length (in)	N/A
N/A	Landing X Slope (%)	N/A	N/A	DWS Full Width?	N/A
N/A	Landing Curb? (Y/N)	N/A	N/A	DWS Offset (in)	N/A
N/A	Shared Landing?	N/A			
N/A	Gutter Ponding?	N/A	N/A	Gutter Slope (%)	N/A
N/A	Gutter Lip Ht (in)	N/A	N/A	Gutter X Slope (%)	N/A
N/A	Painted X Walk1?	Yes	N/A	Painted X Walk2?	Yes
	X Walk 1 Direction	To N		X Walk 2 Direction	To W
N/A	X Walk 1 Width (in)	106.0	N/A	X Walk 2 Width (in)	111.5
	X Walk 1 Slope (%)	3.1		X Walk 2 Slope (%)	0.6
	X Walk 1 X Slope (%)	1.4		X Walk 2 X Slope (%)	1.6

N/A	Ramp inside XWalk1?	Yes	N/A	Ramp inside XWalk2?	Yes
	Road Slope (%)	0.7	N/A	Clear Space?	N/A
	Road X Slope (%)	3.5	N/A	Clear Space to XWalk (in)	N/A
N/A	Any Obstructions?	N/A	N/A	Storm Grate/Utility Hazard?	N/A
	Obstruction Type			Storm Grate/Utility Type	
		N/A			N/A
		Yes		Surface Condition? (G/P)	Good

**Remove & Replace Curb Ramp With Two New Directional Ramps or Equivalent.**
