| Intersection ID: 21161 | Main Street: FOLGER_DR | Cross Street: PROVIDENCE_RD | Location: | NW |
| ADA ID: 3A9D90006989 | Ramp Type: PerpDiag | Initial Pass/Fail: Fail | Overall Compliance: No | Severity Score: 25 |

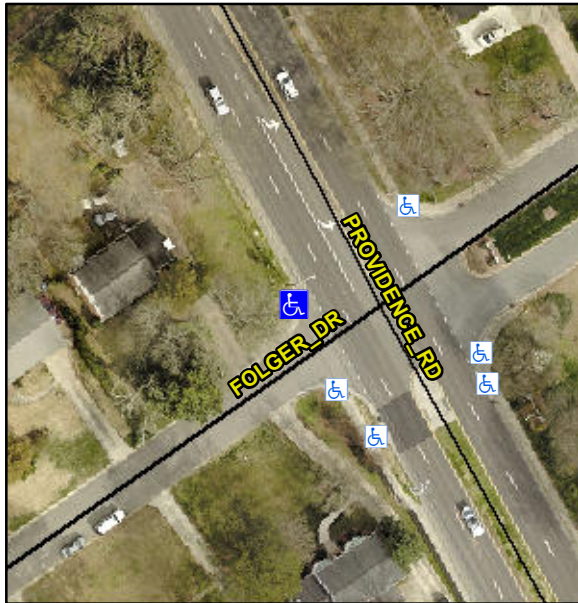
**FOLGER DR**

## StopSign

**PROVIDENCE RD**

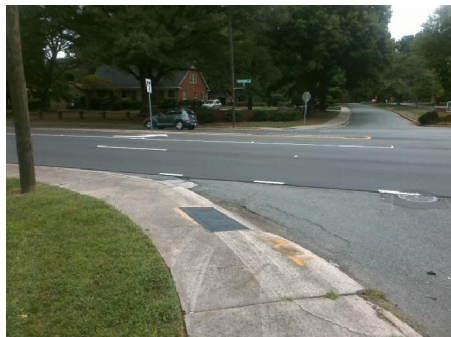
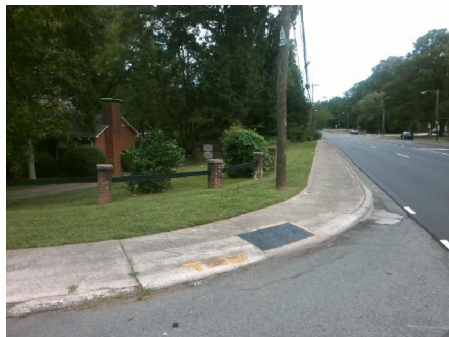
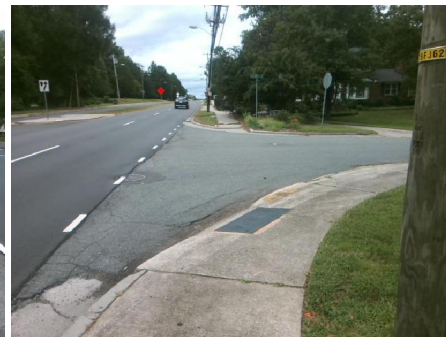
**Not Found, R304.2.2**

| Compliance | Description | Data | Compliance | Description | Data |
|---|---|---|---|---|---|
| N/A | Ramp Length (in) | 55.0 | No | Ramp Slope (%) | 13.1 |

**Remove & Replace Curb Ramp With Two New Directional Ramps or Equivalent.**
