# Access Compliance Report

## Public Rights-of-Way

### (Curb Ramps)

Intersection ID: 46932	Main Street: IDLEWILD_RD_NORTH	Cross Street: SYCAMORE_GROVE_CT	Location: NE
ADA ID: 3AA458024115	Ramp Type: PerpDiag	Initial Pass/Fail: Fail	Overall Compliance: No
Severity Score: 21.25			
Codes/Mitigation Info/Possible Solution		Field Measurements/Component Compliance

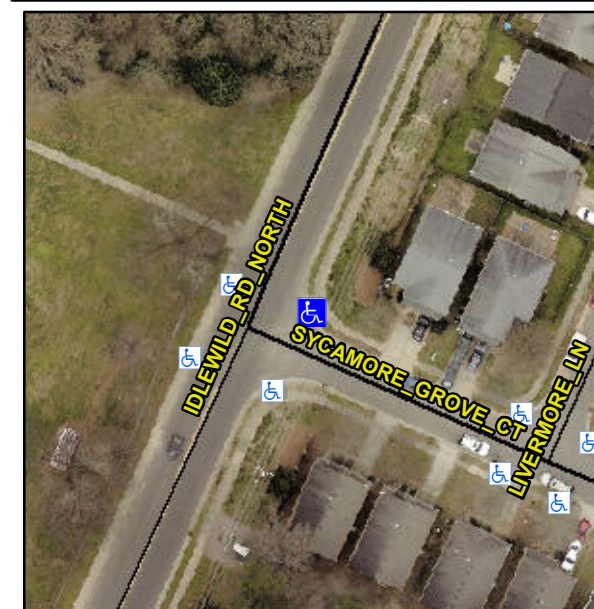
**Not Found, R304.5.1, R304.2.2**

Compliance	Description	Data	Compliance	Description	Data
N/A	Ramp Length (in)	48.0	No	Ramp Slope (%)	9.7
No	Ramp Width (in)	41.0	Yes	Ramp XSlope (%)	0.9
N/A	Flare Type LT	N/A	N/A	Flare Type RT	N/A
N/A	Flare Slope LT (%)	N/A	N/A	Flare Slope RT (%)	N/A
N/A	Flare Traversable LT?	N/A	N/A	Flare Traversable RT?	N/A
N/A	Landing Length (in)	N/A	N/A	DWS Provided?	N/A
N/A	Landing Width (in)	N/A	N/A	DWS Contrast?	N/A
N/A	Landing Slope (%)	N/A	N/A	DWS Length (in)	N/A
N/A	Landing X Slope (%)	N/A	N/A	DWS Full Width?	N/A
N/A	Landing Curb? (Y/N)	N/A	N/A	DWS Offset (in)	N/A
N/A	Shared Landing?	N/A			
N/A	Gutter Ponding?	N/A	N/A	Gutter Slope (%)	N/A
N/A	Gutter Lip Ht (in)	N/A	N/A	Gutter X Slope (%)	N/A
N/A	Painted X Walk1?	No	N/A	Painted X Walk2?	No
	X Walk 1 Direction	To NW		X Walk 2 Direction	To SW
N/A	X Walk 1 Width (in)	N/A	N/A	X Walk 2 Width (in)	N/A
	X Walk 1 Slope (%)	4.2		X Walk 2 Slope (%)	5.0
	X Walk 1 X Slope (%)	1.0		X Walk 2 X Slope (%)	1.8

N/A	Ramp inside XWalk1?	N/A	N/A	Ramp inside XWalk2?	N/A
	Road Slope (%)	0.8	N/A	Clear Space?	N/A
	Road X Slope (%)	0.7	N/A	Clear Space to XWalk (in)	N/A
N/A	Any Obstructions?	N/A	N/A	Storm Grate/Utility Hazard?	N/A
	Obstruction Type			Storm Grate/Utility Type	
		N/A			N/A
		Yes		Surface Condition? (G/P)	Good

**Remove & Replace Curb Ramp With Two New Directional Ramps or Equivalent.**

Total Cost: \$ 3200.00
