Access Compliance Report Public Rights-of-Way (Curb Ramps)

Intersection ID: 12164 Main Street: SEIGLE AV **Cross Street: BELMONT AV** Location: ADA ID: 3AB5D29DF1C3 Ramp Type: BlendTrans1 Initial Pass/Fail: Fail **Overall Compliance: No** Severity Score: 33.75

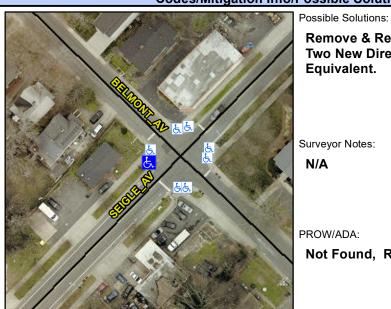
Surveyor Notes:				
PROW/ADA:				
Not Found,	R304.5.1,	R304.5.3	3	
Total Cost:		\$	3200 00

Compliance Description Data		Compliance Description		Data	
N/A	Ramp Length (in)	74.0	Yes	BlendTrans Slope (%)	0.7
No	Ramp Width (in)	47.5	No	BlendTrans XSlope (%)	8.1
N/A	Flare Type LT	N/A	N/A	Flare Type RT	N/A
N/A	Flare Slope LT (%)	N/A	N/A	Flare Slope RT (%)	N/A
N/A	Flare Traversable LT?	N/A	N/A	Flare Traversable RT?	N/A
N/A	Landing Length (in)	N/A	N/A	DWS Provided?	N/A
N/A	Landing Width (in)	N/A	N/A	DWS Contrast?	N/A
N/A	Landing Slope (%)	N/A	N/A	DWS Length (in)	N/A
N/A	Landing X Slope (%)	N/A	N/A	DWS Full Width?	N/A
N/A	Landing Curb? (Y/N)	N/A	N/A	DWS Offset (in)	N/A
N/A	Shared Landing?	N/A			
N/A	Gutter Ponding?	N/A	N/A	Gutter Slope (%)	N/A
N/A	Gutter Lip Ht (in)	N/A	N/A	Gutter X Slope (%)	N/A
N/A	Painted X Walk1?	No	N/A	Painted X Walk2?	N/A
	X Walk 1 Direction	To SE		X Walk 2 Direction	N/A
	X Walk 1 Width (in)	N/A		X Walk 2 Width (in)	N/A
	X Walk 1 Slope (%)	6.2		X Walk 2 Slope (%)	N/A
	X Walk 1 X Slope (%)	2.4		X Walk 2 X Slope (%)	N/A

N/A	Ramp inside XWalk1?	N/A	N/A	Ramp inside XWalk2?	N/A
	Road Slope (%)	2.4		Clear Space?	N/A
	Road X Slope (%)	6.2	N/A	Clear Space to XWalk (in)	N/A
N/A	Any Obstructions?	N/A	N/A	Storm Grate/Utility Hazard?	N/A
	Obstruction Type			Storm Grate/Utility Type	
		N/A			N/A
			Yes	Surface Condition? (G/P)	Good
			No	Curb Slope (%)	16.2

SEIGLE AV Street 1 Name Stop Condition-Street 1 None Street 2 Name N/A Stop Condition-Street 2 N/A Remove & Replace Curb Ramp With **Two New Directional Ramps or** Equivalent.
