Access Compliance Report

Public Rights-of-Way

(Curb Ramps)

Intersection ID: 18546	Main Street: MONROE_RD	Cross Street: PINEBOROUGH_RD	Location: SE
ADA ID: 3AC6FEDB07F7	Ramp Type: PerpDiag	Initial Pass/Fail: Fail	Overall Compliance: No
			Severity Score: 13.75

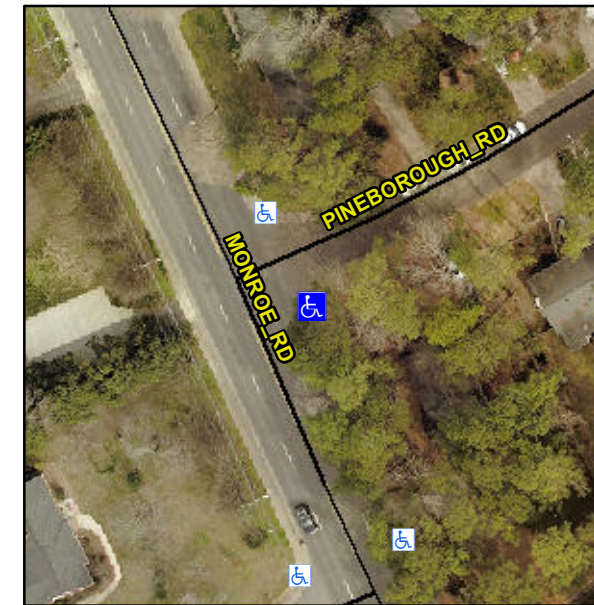
Not Found, R304.2.2, R304.5.3

Compliance	Description	Data	Compliance	Description	Data
N/A	Ramp Length (in)	62.0	No	Ramp Slope (%)	9.0
Yes	Ramp Width (in)	48.0	No	Ramp XSlope (%)	4.5
N/A	Flare Type LT	N/A	N/A	Flare Type RT	N/A
N/A	Flare Slope LT (%)	N/A	N/A	Flare Slope RT (%)	N/A
N/A	Flare Traversable LT?	N/A	N/A	Flare Traversable RT?	N/A
N/A	Landing Length (in)	N/A	N/A	DWS Provided?	N/A
N/A	Landing Width (in)	N/A	N/A	DWS Contrast?	N/A
N/A	Landing Slope (%)	N/A	N/A	DWS Length (in)	N/A
N/A	Landing X Slope (%)	N/A	N/A	DWS Full Width?	N/A
N/A	Landing Curb? (Y/N)	N/A	N/A	DWS Offset (in)	N/A
N/A	Shared Landing?	N/A			
N/A	Gutter Ponding?	N/A	N/A	Gutter Slope (%)	N/A
N/A	Gutter Lip Ht (in)	N/A	N/A	Gutter X Slope (%)	N/A
N/A	Painted X Walk1?	No	N/A	Painted X Walk2?	No
	X Walk 1 Direction	To N		X Walk 2 Direction	To W
N/A	X Walk 1 Width (in)	N/A	N/A	X Walk 2 Width (in)	N/A
	X Walk 1 Slope (%)	2.9		X Walk 2 Slope (%)	2.9
	X Walk 1 X Slope (%)	5.2		X Walk 2 X Slope (%)	1.1

N/A	Ramp inside XWalk1?	N/A	N/A	Ramp inside XWalk2?	N/A
	Road Slope (%)	3.4	N/A	Clear Space?	N/A
	Road X Slope (%)	5.8	N/A	Clear Space to XWalk (in)	N/A
N/A	Any Obstructions?	N/A	N/A	Storm Grate/Utility Hazard?	N/A
	Obstruction Type			Storm Grate/Utility Type	
		N/A			N/A
			Yes	Surface Condition? (G/P)	Good

Possible Solutions:

Remove & Replace Curb Ramp With Two New Directional Ramps or Equivalent.
