Access Compliance Report

Public Rights-of-Way

(Curb Ramps)

Intersection ID: 5420	Main Street: CARVER_PL	Cross Street: ROCKWELL_BV_WEST	Location: N
ADA ID: 3ACFCA6E6035	Ramp Type: Para	Initial Pass/Fail: Fail	Overall Compliance: No
Severity Score: 21.25			
Codes/Mitigation Info/Possible Solution		Field Measurements/Component Compliance

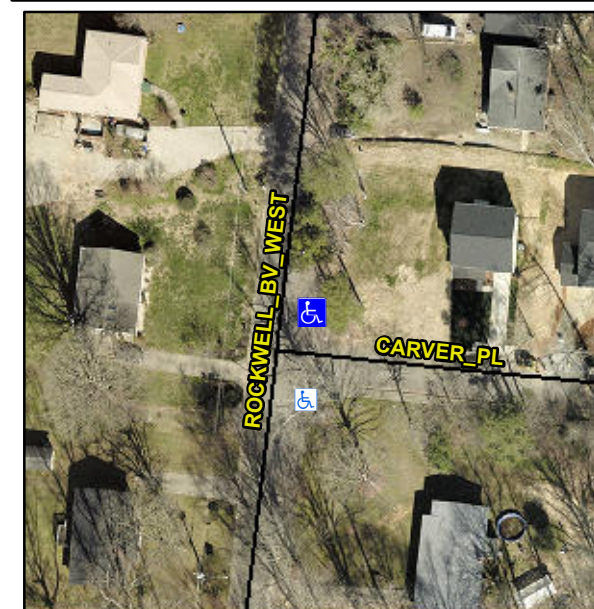
LT RP < 5%

PROW/ADA:

R304.5.1, R304.3.2

Compliance	Description	Data	Compliance	Description	Data
N/A	Ramp Length LT (in)	61.0	N/A	Ramp Length RT (in)	64.0
Yes	Ramp Width LT (in)	60.0	No	Ramp Width RT (in)	36.0
Yes	Ramp Slope LT (%)	4.7	No	Ramp Slope RT (%)	8.8
Yes	Ramp XSlope LT (%)	0.7	Yes	Ramp XSlope RT (%)	1.7
N/A	Landing Length (in)	N/A	N/A	DWS Provided?	N/A
N/A	Landing Width (in)	N/A	N/A	DWS Contrast?	N/A
N/A	Landing Slope (%)	N/A	N/A	DWS Length (in)	N/A
N/A	Landing X Slope (%)	N/A	N/A	DWS Full Width?	N/A
N/A	Landing Curb? (Y/N)	N/A	N/A	DWS Offset (in)	N/A
N/A	Shared Landing?	N/A			
N/A	Gutter Ponding?	N/A	N/A	Gutter Slope (%)	N/A
N/A	Gutter Lip Ht (in)	N/A	N/A	Gutter X Slope (%)	N/A
N/A	Painted X Walk1?	No	N/A	Painted X Walk2?	N/A
	X Walk 1 Direction	To S		X Walk 2 Direction	N/A
N/A	X Walk 1 Width (in)	N/A	N/A	X Walk 2 Width (in)	N/A
	X Walk 1 Slope (%)	3.5		X Walk 2 Slope (%)	N/A
	X Walk 1 X Slope (%)	1.6		X Walk 2 X Slope (%)	N/A
N/A	Ramp inside XWalk1?	N/A	N/A	Ramp inside XWalk2?	N/A

Road Slope (%)	N/A	N/A	Clear Space?	N/A
	Road X Slope (%)	N/A	N/A	Clear Space to XWalk (in)	N/A
N/A	Any Obstructions?	N/A	N/A	Storm Grate/Utility Hazard?	N/A
	Obstruction Type			Storm Grate/Utility Type	
		N/A			N/A
			Yes	Surface Condition? (G/P)	Good
			N/A	Curb Slope (%)	12.3

Possible Solutions:

Remove & Replace Entire Ramp.
