Access Compliance Report

Public Rights-of-Way

(Curb Ramps)

Intersection ID: 13414	Main Street: MCCLINTOCK_RD	Cross Street: ST_JULIEN_ST	Location: S
ADA ID: 3AD3FAFA9D09	Ramp Type: Perp	Initial Pass/Fail: Fail	Overall Compliance: No
		Severity Score: 22.5

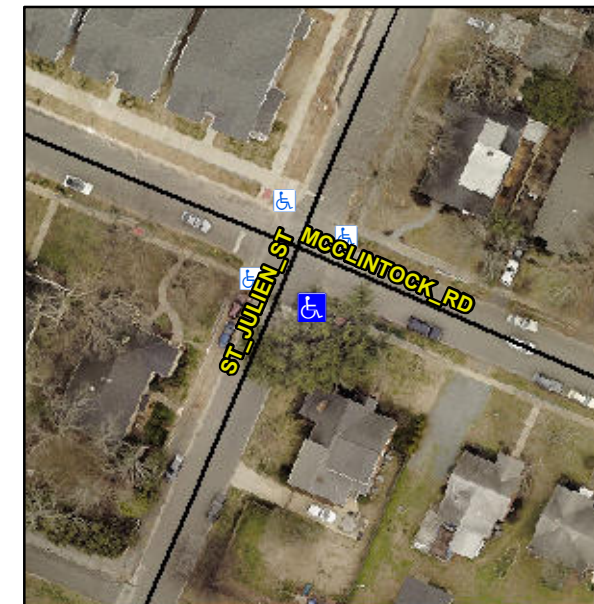
Compliance	Description	Data	Compliance	Description	Data
N/A	Ramp Length (in)	55.0	No	Ramp Slope (%)	8.4
No	Ramp Width (in)	47.0	No	Ramp XSlope (%)	3.3
N/A	Flare Type LT	N/A	N/A	Flare Type RT	N/A
N/A	Flare Slope LT (%)	N/A	N/A	Flare Slope RT (%)	N/A
N/A	Flare Traversable LT?	N/A	N/A	Flare Traversable RT?	N/A
N/A	Landing Length (in)	N/A	N/A	DWS Provided?	N/A
N/A	Landing Width (in)	N/A	N/A	DWS Contrast?	N/A
N/A	Landing Slope (%)	N/A	N/A	DWS Length (in)	N/A
N/A	Landing X Slope (%)	N/A	N/A	DWS Full Width?	N/A
N/A	Landing Curb? (Y/N)	N/A	N/A	DWS Offset (in)	N/A
N/A	Shared Landing?	N/A			
N/A	Gutter Ponding?	N/A	N/A	Gutter Slope (%)	N/A
N/A	Gutter Lip Ht (in)	N/A	N/A	Gutter X Slope (%)	N/A
N/A	Painted X Walk1?	No	N/A	Painted X Walk2?	N/A
	X Walk 1 Direction	To NW		X Walk 2 Direction	N/A
N/A	X Walk 1 Width (in)	N/A	N/A	X Walk 2 Width (in)	N/A
	X Walk 1 Slope (%)	2.9		X Walk 2 Slope (%)	N/A
	X Walk 1 X Slope (%)	3.3		X Walk 2 X Slope (%)	N/A

N/A	Ramp inside XWalk1?	N/A	N/A	Ramp inside XWalk2?	N/A
	Road Slope (%)	N/A	N/A	Clear Space?	N/A
	Road X Slope (%)	N/A	N/A	Clear Space to XWalk (in)	N/A
N/A	Any Obstructions?	N/A	N/A	Storm Grate/Utility Hazard?	N/A
	Obstruction Type			Storm Grate/Utility Type	
		N/A			N/A
			Yes	Surface Condition? (G/P)	Good

Possible Solutions:

Remove & Replace Entire Ramp.

R304.5.1, R304.2.2, R304.5.3
