# Access Compliance Report

## Public Rights-of-Way

### (Curb Ramps)

| Intersection ID: 10020377 | Main Street: BALLANTYNE_CORPORATE_PL | Cross Street: N/A | Location: SW |

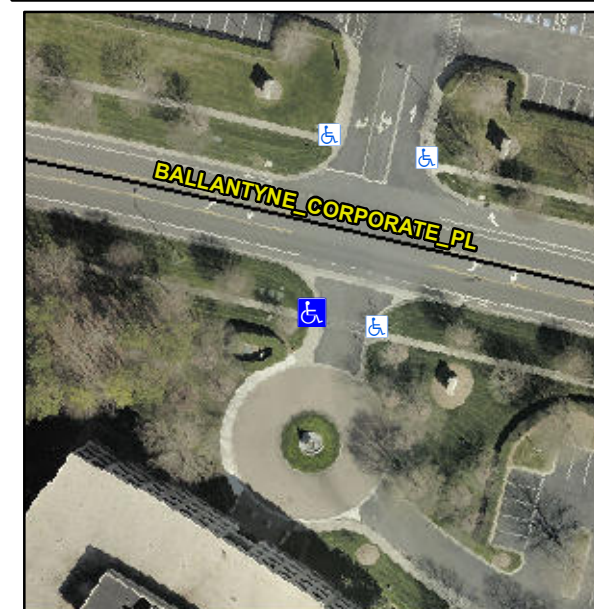
**Not Found, R304.5.1, R304.5.3**

| Compliance | Description | Data | Compliance | Description | Data |
|---|---|---|---|---|---|
| N/A | Ramp Length (in) | 58.0 | Yes | Ramp Slope (%) | 6.3 |
| No | Ramp Width (in) | 46.0 | No | Ramp XSlope (%) | 12.0 |

**Remove & Replace Entire Ramp.**

Total Cost: \$ 1850.00
