| Intersection ID: 43146 | Main Street: EASTWAY_DR | Cross Street: EASTWAY_DR_RA | Location: | SW |
| ADA ID: 3ADE434C24D8 | Ramp Type: Perp | Initial Pass/Fail: Fail | Overall Compliance: No | Severity Score: 13.75 |

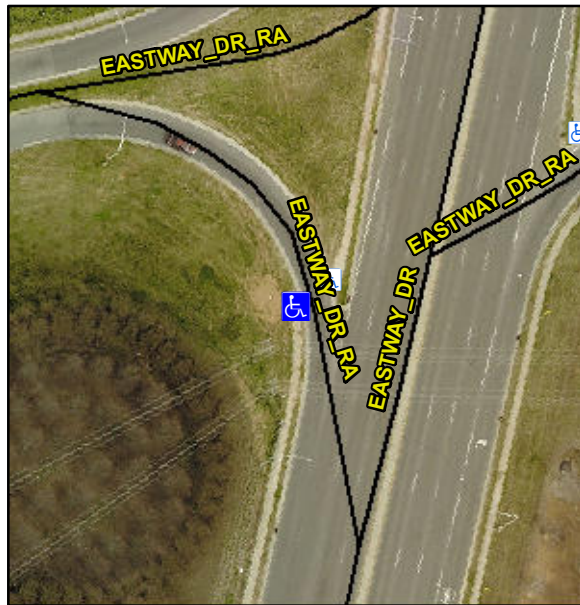
Not Found, R304.2.2

| Compliance | Description | Data | Compliance | Description | Data |
|---|---|---|---|---|---|
| N/A | Ramp Length (in) | 82.5 | No | Ramp Slope (%) | 8.5 |
| Yes | Ramp Width (in) | 57.0 | Yes | Ramp XSlope (%) | 3.7 |

Remove & Replace Entire Ramp.
