Access Compliance Report Public Rights-of-Way (Curb Ramps)

Intersection ID: 6928 Main Street: CRAWFORD_DR Cross Street: PLUMSTEAD_RD Location: S

ADA ID: 3AE5FDD65D72 Ramp Type: Perp Initial Pass/Fail: Fail Overall Compliance: No Severity Score: 33.75

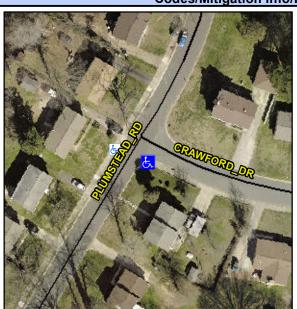
Possible Solutions:	<u>c</u>	
Remove & Replace Entire Ramp.		
·	N	
	N	
	N	
	N	
	N	
Surveyor Notes:	N	
N/A	N	
	N	
	N	
	N	
PROW/ADA:	N	
Not Found, R304.5.1, R304.5.3	N	
	N	
	N	
	N

u33/1	an. ran Overan	Compilar	icc. it	o deventy ocore.	33.7	
Field Measurements/Component Compliance						
Comp	liance Description	Data	Comp	liance Description	Data	
N/A	Ramp Length (in)	60.0	Yes	Ramp Slope (%)	7.6	
No	Ramp Width (in)	39.0	No	Ramp XSlope (%)	12.6	
N/A	Flare Type LT	N/A	N/A	Flare Type RT	N/A	
N/A	Flare Slope LT (%)	N/A	N/A	Flare Slope RT (%)	N/A	
N/A	Flare Traversable LT?	N/A	N/A	Flare Traversable RT?	N/A	
N/A	Landing Length (in)	N/A	N/A	DWS Provided?	N/A	
N/A	Landing Width (in)	N/A	N/A	DWS Contrast?	N/A	
N/A	Landing Slope (%)	N/A	N/A	DWS Length (in)	N/A	
N/A	Landing X Slope (%)	N/A	N/A	DWS Full Width?	N/A	
N/A	Landing Curb? (Y/N)	N/A	N/A	DWS Offset (in)	N/A	
N/A	Shared Landing?	N/A				
N/A	Gutter Ponding?	N/A	N/A	Gutter Slope (%)	N/A	
N/A	Gutter Lip Ht (in)	N/A	N/A	Gutter X Slope (%)	N/A	
N/A	Painted X Walk1?	No	N/A	Painted X Walk2?	N/A	
	X Walk 1 Direction	To NW		X Walk 2 Direction	N/A	
N/A	X Walk 1 Width (in)	N/A	N/A	X Walk 2 Width (in)	N/A

X Walk 1 Slope (%)	1.0		X Walk 2 Slope (%)	N/A	
	X Walk 1 X Slope (%)	6.7		X Walk 2 X Slope (%)	N/A	
N/A	Ramp inside XWalk1?	N/A	N/A	Ramp inside XWalk2?	N/A	
	Road Slope (%)	N/A	N/A	Clear Space?	N/A	
	Road X Slope (%)	N/A	N/A	Clear Space to XWalk (in)	N/A	
N/A	Any Obstructions?	N/A	N/A	Storm Grate/Utility Hazard?	N/A	
	Obstruction Type			Storm Grate/Utility Type		
		N/A			N/A	
			Yes	Surface Condition? (G/P)	Good
