# Access Compliance Report

## Public Rights-of-Way

### (Curb Ramps)

| Intersection ID: 12611 | Main Street: S_CHURCH_ST | Cross Street: W_STONEWALL_ST | Location: E |

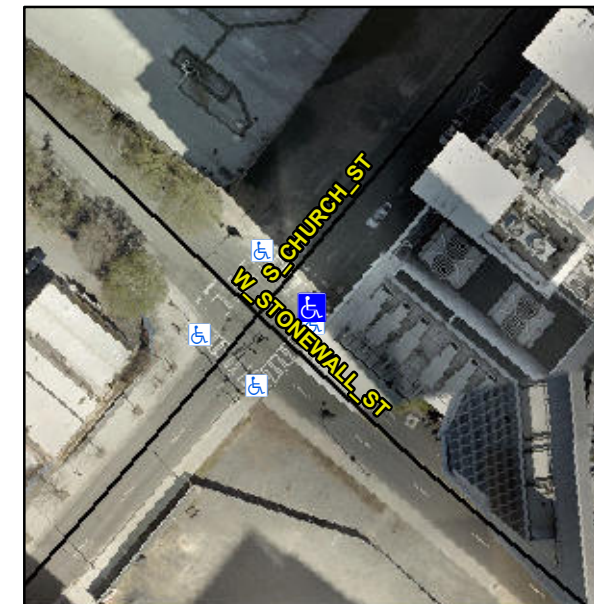
| ADA ID: 3AF7CE036F06 | Ramp Type: Perp | Initial Pass/Fail: Pass | Overall Compliance: No |
| | | Severity Score: 7.5 | |

| Compliance | Description | Data | Compliance | Description | Data |
|---|---|---|---|---|---|
| No | Gutter Lip Ht (in) | 0.5 | Yes | Gutter X Slope (%) | 0.1 |

**Grind Gutter Lip.**

**R302.7.2**

Total Cost: \$ 200.00
