# Access Compliance Report

## Public Rights-of-Way

### (Curb Ramps)

| Intersection ID: 44317 | Main Street: E_9TH_ST | Cross Street: N_CALDWELL_ST | Location: W |

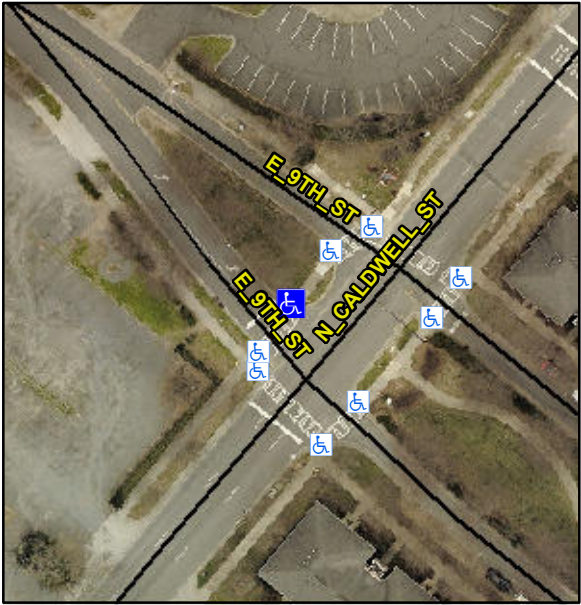
| ADA ID: 3AFA64D2F911 | Ramp Type: Perp | Initial Pass/Fail: Fail | Overall Compliance: No |

| Codes/Mitigation Info/Possible Solution | | | Field Measurements/Component Compliance | | |
|---|--|--|---|---|---|
| | <b>Remove &amp; Replace Entire Ramp.</b> | | <b>No</b> | Ramp Length (in) | 52.0 |
| | | | <b>No</b> | Ramp Width (in) | 47.0 |
| <p>Surveyor Notes:</p> <p><b>N/A</b></p> <p>PROW/ADA:</p> <p><b>Not Found, R304.5.1, R304.2.2</b></p> | | | <b>N/A</b> | Flare Type RT | N/A |

| Codes/Mitigation Info/Possible Solution | | | Field Measurements/Component Compliance | | |
|---|--|--|---|---|---|
| | Possible Solutions: | | <b>Compliance</b> | <b>Description</b> | <b>Data</b> |
| <p>Total Cost:</p> <p><b>\$ 1850.00</b></p> | | | <b>Yes</b> | Painted X Walk1? | N/A |
