Intersection ID: 44684	Main Street: CEDAR_CROFT_DR	Cross Street: LARRISA_CT	Location:	NE
ADA ID: 3B024750FCF2	Ramp Type: PerpDiag	Initial Pass/Fail: Fail	Overall Compliance: No	Severity Score: 58.75

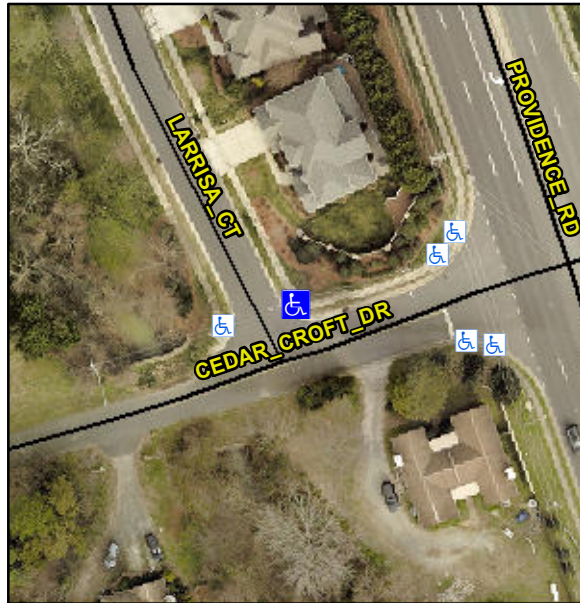
**Not Found, R304.5.1, R304.2.2,
R304.5.3**

Compliance	Description	Data	Compliance	Description	Data
N/A	Ramp Length (in)	48.0	No	Ramp Slope (%)	13.2
No	Ramp Width (in)	44.0	No	Ramp XSlope (%)	13.0
N/A	Flare Type LT	N/A	N/A	Flare Type RT	N/A
N/A	Flare Slope LT (%)	N/A	N/A	Flare Slope RT (%)	N/A
N/A	Flare Traversable LT?	N/A	N/A	Flare Traversable RT?	N/A
N/A	Landing Length (in)	N/A	N/A	DWS Provided?	N/A
N/A	Landing Width (in)	N/A	N/A	DWS Contrast?	N/A
N/A	Landing Slope (%)	N/A	N/A	DWS Length (in)	N/A
N/A	Landing X Slope (%)	N/A	N/A	DWS Full Width?	N/A
N/A	Landing Curb? (Y/N)	N/A	N/A	DWS Offset (in)	N/A
N/A	Shared Landing?	N/A			
N/A	Gutter Ponding?	N/A	N/A	Gutter Slope (%)	N/A
N/A	Gutter Lip Ht (in)	N/A	N/A	Gutter X Slope (%)	N/A
N/A	Painted X Walk1?	No	N/A	Painted X Walk2?	No
	X Walk 1 Direction	To W		X Walk 2 Direction	To S
N/A	X Walk 1 Width (in)	N/A	N/A	X Walk 2 Width (in)	N/A
	X Walk 1 Slope (%)	4.4		X Walk 2 Slope (%)	2.3
	X Walk 1 X Slope (%)	5.8		X Walk 2 X Slope (%)	9.2

N/A	Ramp inside XWalk1?	N/A	N/A	Ramp inside XWalk2?	N/A
	Road Slope (%)	9.1	N/A	Clear Space?	N/A
	Road X Slope (%)	2.8	N/A	Clear Space to XWalk (in)	N/A
N/A	Any Obstructions?	N/A	N/A	Storm Grate/Utility Hazard?	N/A
	Obstruction Type			Storm Grate/Utility Type	
		N/A			N/A
			Yes	Surface Condition? (G/P)	Good

Remove & Replace Curb Ramp With Two New Directional Ramps or Equivalent.

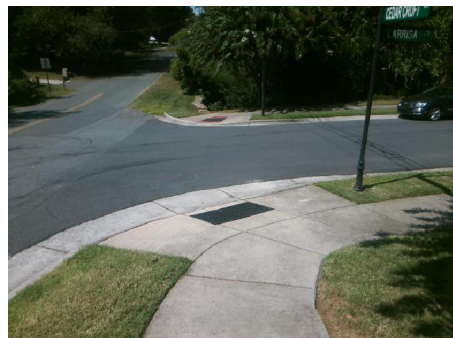
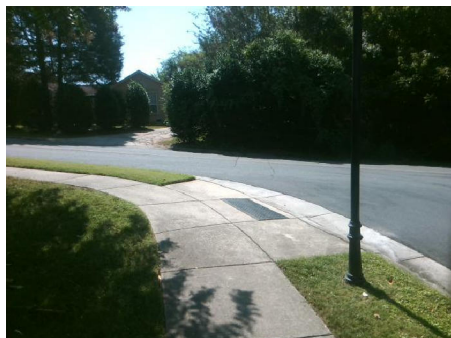
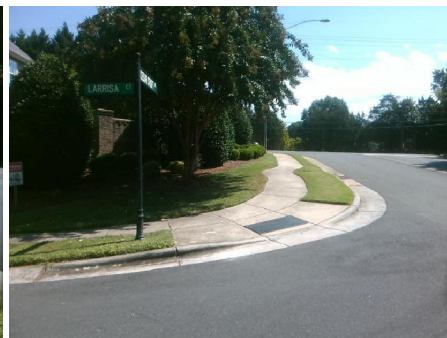
Street 1 Name	LARRISA CT
Stop Condition-Street 2	StopSign
Street 2 Name	CEDAR CROFT DR
Stop Condition-Street 1	None
