## Access Compliance Report Public Rights-of-Way (Curb Ramps)

Intersection ID: 19151 Main Street: ECHODALE\_DR Cross Street: EDGEGREEN\_DR Location: SE

ADA ID: 3B0BCF5497D5 Ramp Type: PerpDiag Initial Pass/Fail: Fail Overall Compliance: No Severity Score: 26.25

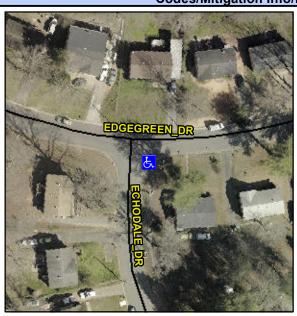
Not Found, R304.2.2, R304.5.3

Fleid Measurements/Component Compliance						
	Comp	Compliance Description		Compliance Description		Data
	N/A	Ramp Length (in)	55.0	No	Ramp Slope (%)	16.1
	Yes	Ramp Width (in)	48.0	No	Ramp XSlope (%)	3.0
	N/A	Flare Type LT	N/A	N/A	Flare Type RT	N/A
	N/A	Flare Slope LT (%)	N/A	N/A	Flare Slope RT (%)	N/A
	N/A	Flare Traversable LT?	N/A	N/A	Flare Traversable RT?	N/A
	N/A	Landing Length (in)	N/A	N/A	DWS Provided?	N/A
	N/A	Landing Width (in)	N/A	N/A	DWS Contrast?	N/A
	N/A	Landing Slope (%)	N/A	N/A	DWS Length (in)	N/A
	N/A	Landing X Slope (%)	N/A	N/A	DWS Full Width?	N/A
	N/A	Landing Curb? (Y/N)	N/A	N/A	DWS Offset (in)	N/A
	N/A	Shared Landing?	N/A			
	N/A	Gutter Ponding?	N/A	N/A	Gutter Slope (%)	N/A
	N/A	Gutter Lip Ht (in)	N/A	N/A	Gutter X Slope (%)	N/A
	N/A	Painted X Walk1?	No	N/A	Painted X Walk2?	No
		X Walk 1 Direction	To N		X Walk 2 Direction	To W
	N/A	X Walk 1 Width (in)	N/A	N/A	X Walk 2 Width (in)	N/A
		X Walk 1 Slope (%)	1.5		X Walk 2 Slope (%)	1.5

X Walk 1 X Slope (%)	1.9		X Walk 2 X Slope (%)	2.2
	N/A	Ramp inside XWalk1?	N/A	N/A	Ramp inside XWalk2?	N/A
		Road Slope (%)	3.2	N/A	Clear Space?	N/A
		Road X Slope (%)	2.4	N/A	Clear Space to XWalk (in)	N/A
	N/A	Any Obstructions?	N/A	N/A	Storm Grate/Utility Hazard?	N/A
		Obstruction Type		l	Storm Grate/Utility Type	
			N/A			N/A
				Yes	Surface Condition? (G/P)	Good

Remove & Replace Curb Ramp With Two New Directional Ramps or Equivalent.
