Access Compliance Report

Public Rights-of-Way

(Curb Ramps)

Intersection ID: N/A	Main Street: POINDEXTER_DR	Cross Street: YOUNGBLOOD_ST	Location: N
ADA ID: 3B0D40ABC222	Ramp Type: Directional1	Initial Pass/Fail: Fail	Overall Compliance: No
		Severity Score: 12.5

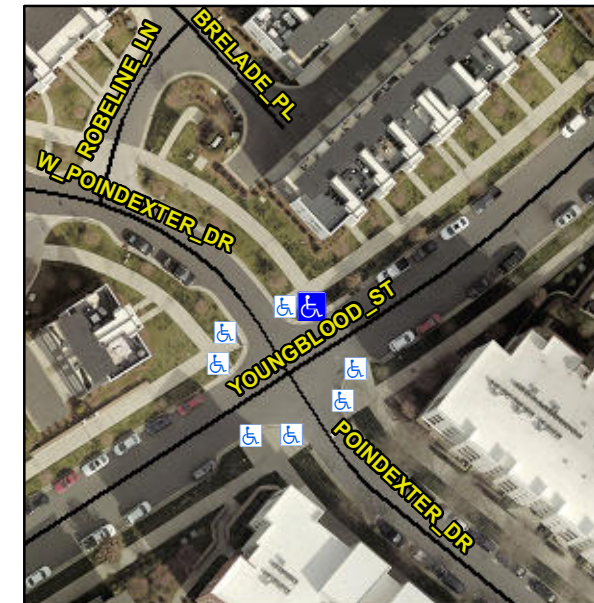
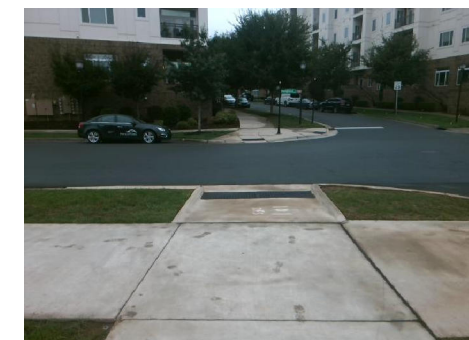
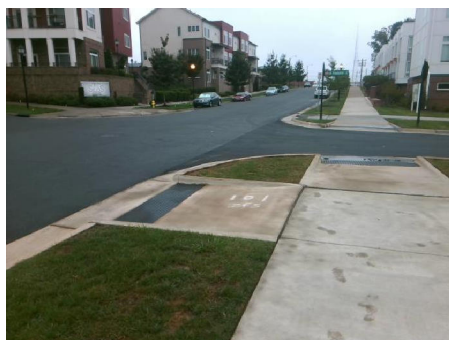
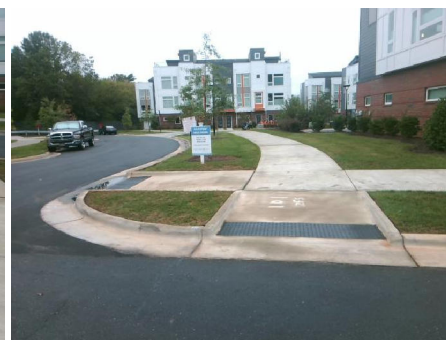
Compliance	Description	Data	Compliance	Description	Data
N/A	Ramp Length (in)	96.0	N/A	Grade Break?	N/A
Yes	Ramp Width (in)	92.0	N/A	Grade Break Slope (%)	0.0
No	Ramp Slope (%)	9.4	N/A	Grade Break XSlope (%)	0.0
Yes	Ramp XSlope (%)	0.0			
N/A	Flare Type LT	N/A	N/A	Flare Type RT	N/A
N/A	Flare Slope LT (%)	N/A	N/A	Flare Slope RT (%)	0.0
N/A	Flare Traversable LT?	N/A	N/A	Flare Traversable RT?	N/A
N/A	Landing Length (in)	0.0	N/A	DWS Provided?	N/A
N/A	Landing Width (in)	0.0	N/A	DWS Contrast?	N/A
N/A	Landing Slope (%)	0.0	N/A	DWS Length (in)	N/A
N/A	Landing X Slope (%)	0.0	N/A	DWS Full Width?	N/A
N/A	Landing Curb? (Y/N)	N/A	N/A	DWS Offset LT (in)	N/A
N/A	Shared Landing?	N/A	N/A	DWS Offset RT (in)	N/A
N/A	Gutter Ponding?	0.0	N/A	Gutter Slope (%)	N/A
N/A	Gutter Lip Ht (in)	0.0	N/A	Gutter X Slope (%)	N/A
N/A	Painted X Walk1?	No		Road Slope (%)	3.0
	X Walk 1 Direction	To SE		Road X Slope (%)	1.2
	X Walk 1 Width (in)	N/A		Clear Space?	N/A

X Walk 1 Slope (%)	3.0	N/A	Clear Space to XWalk (in)	N/A
	X Walk 1 X Slope (%)	1.2	N/A	Storm Grate/Utility Hazard?	N/A
N/A	Ramp inside XWalk1?	N/A		Storm Grate/Utility Type	
N/A	Any Obstructions?	N/A			N/A
	Obstruction Type		Yes	Surface Condition? (G/P)	Good
			N/A	Curb Slope (%)	13.6

Remove & Replace Entire Ramp.

R304.2.2
