Access Compliance Report

Public Rights-of-Way

(Curb Ramps)

Intersection ID: 17138	Main Street: IDLEWILD_RD	Cross Street: PINEY_GROVE_RD	Location: SE
ADA ID: 3B11C2AB06C4	Ramp Type: BlendTrans1	Initial Pass/Fail: Fail	Overall Compliance: No
Severity Score: 8.75			
Codes/Mitigation Info/Possible Solution		Field Measurements/Component Compliance

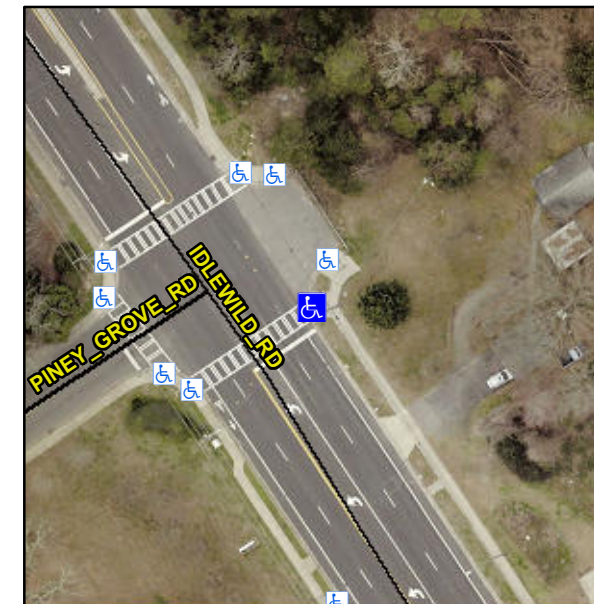
Not Found, R304.5.1

Compliance	Description	Data	Compliance	Description	Data
N/A	Ramp Length (in)	96.0	Yes	BlendTrans Slope (%)	1.4
No	Ramp Width (in)	44.0	Yes	BlendTrans XSlope (%)	0.3
N/A	Flare Type LT	N/A	N/A	Flare Type RT	N/A
N/A	Flare Slope LT (%)	N/A	N/A	Flare Slope RT (%)	N/A
N/A	Flare Traversable LT?	N/A	N/A	Flare Traversable RT?	N/A
N/A	Landing Length (in)	N/A	N/A	DWS Provided?	N/A
N/A	Landing Width (in)	N/A	N/A	DWS Contrast?	N/A
N/A	Landing Slope (%)	N/A	N/A	DWS Length (in)	N/A
N/A	Landing X Slope (%)	N/A	N/A	DWS Full Width?	N/A
N/A	Landing Curb? (Y/N)	N/A	N/A	DWS Offset (in)	N/A
N/A	Shared Landing?	N/A			
N/A	Gutter Ponding?	N/A	N/A	Gutter Slope (%)	N/A
N/A	Gutter Lip Ht (in)	N/A	N/A	Gutter X Slope (%)	N/A
N/A	Painted X Walk1?	Yes	N/A	Painted X Walk2?	N/A
	X Walk 1 Direction	To SW		X Walk 2 Direction	N/A
	X Walk 1 Width (in)	111.0		X Walk 2 Width (in)	N/A
	X Walk 1 Slope (%)	0.9		X Walk 2 Slope (%)	N/A
	X Walk 1 X Slope (%)	2.0		X Walk 2 X Slope (%)	N/A

N/A	Ramp inside XWalk1?	Yes	N/A	Ramp inside XWalk2?	N/A
	Road Slope (%)	2.0		Clear Space?	N/A
	Road X Slope (%)	0.9	N/A	Clear Space to XWalk (in)	N/A
N/A	Any Obstructions?	N/A	N/A	Storm Grate/Utility Hazard?	N/A
	Obstruction Type			Storm Grate/Utility Type	
		N/A			N/A
			Yes	Surface Condition? (G/P)	Good
			No	Curb Slope (%)	8.2

Remove & Replace Curb Ramp With Two New Directional Ramps or Equivalent.
