Access Compliance Report Public Rights-of-Way (Curb Ramps)

Intersection ID: 18369Main Street:RUNNYMEDE_LNCross Street:WINDSOR_DRLocation:SWADA ID: 3B3592BEF0CARamp Type:PerpDiagInitial Pass/Fail:FailOverall Compliance:NoSeverity Score:25

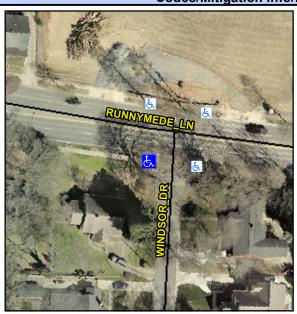
Field Measurements/Component Compnance						
Compliance Description		Data	Compliance Description		Data	
N/A	Ramp Length (in)	64.0	No	Ramp Slope (%)	11.4	
Yes	Ramp Width (in)	55.0	No	Ramp XSlope (%)	5.8	
N/A	Flare Type LT	N/A	N/A	Flare Type RT	N/A	
N/A	Flare Slope LT (%)	N/A	N/A	Flare Slope RT (%)	N/A	
N/A	Flare Traversable LT?	N/A	N/A	Flare Traversable RT?	N/A	
N/A	Landing Length (in)	N/A	N/A	DWS Provided?	N/A	
N/A	Landing Width (in)	N/A	N/A	DWS Contrast?	N/A	
N/A	Landing Slope (%)	N/A	N/A	DWS Length (in)	N/A	
N/A	Landing X Slope (%)	N/A	N/A	DWS Full Width?	N/A	
N/A	Landing Curb? (Y/N)	N/A	N/A	DWS Offset (in)	N/A	
N/A	Shared Landing?	N/A				
N/A	Gutter Ponding?	N/A	N/A	Gutter Slope (%)	N/A	
N/A	Gutter Lip Ht (in)	N/A	N/A	Gutter X Slope (%)	N/A	
N/A	Painted X Walk1?	No	N/A	Painted X Walk2?	No	
	X Walk 1 Direction	To E		X Walk 2 Direction	To N	
N/A	X Walk 1 Width (in)	N/A	N/A	X Walk 2 Width (in)	N/A	
	X Walk 1 Slope (%)	5.2		X Walk 2 Slope (%)	3.2

X Walk 1 X Slope (%)	6.0		X Walk 2 X Slope (%)	6.1	
N/A	Ramp inside XWalk1?	N/A	N/A	Ramp inside XWalk2?	N/A	
	Road Slope (%)	6.4	N/A	Clear Space?	N/A	
	Road X Slope (%)	1.4	N/A	Clear Space to XWalk (in)	N/A	
N/A	Any Obstructions?	N/A	N/A	Storm Grate/Utility Hazard?	N/A	
	Obstruction Type			Storm Grate/Utility Type		
		N/A			N/A	
			Yes	Surface Condition? (G/P)	Good

Possible Solutions:
Remove & Replace Curb Ramp With Two New Directional Ramps or Equivalent.
Surveyor Notes: N/A
PROW/ADA: Not Found, R304.2.2, R304.5.3
