Access Compliance Report

Public Rights-of-Way

(Curb Ramps)

Intersection ID: N/A	Main Street: HUNTERS_CROSSING_LN	Cross Street: THE_PLAZA	Location: SW
ADA ID: 3B5E12E5ED22	Ramp Type: Combination2Diag	Initial Pass/Fail: Fail	Overall Compliance: No
		Severity Score: 0

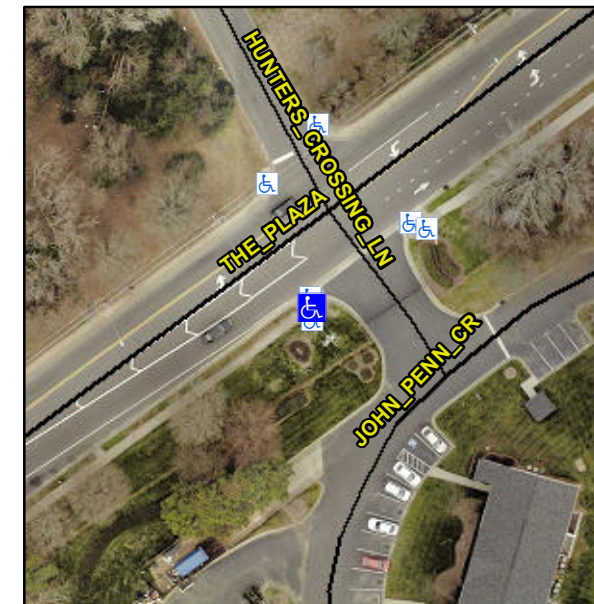
Not Found, R304.5.1, R304.5.3

Compliance	Description	Data	Compliance	Description	Data
N/A	Ramp Length LT (in)	30.0	N/A	Ramp Length RT (in)	45.5
Yes	Ramp Width LT (in)	54.5	Yes	Ramp Width RT (in)	61.0
Yes	Ramp Slope LT (%)	4.2	Yes	Ramp Slope RT (%)	5.2
No	Ramp XSlope LT (%)	2.7	Yes	Ramp XSlope RT (%)	0.6
N/A	Ramp Length (in)	48.0	Yes	Ramp Slope (%)	2.5
No	Ramp Width (in)	47.0	Yes	Ramp XSlope (%)	1.3
N/A	Flare Type LT	N/A	N/A	Flare Type RT	N/A
N/A	Flare Slope LT (%)	N/A	N/A	Flare Slope RT (%)	N/A
N/A	Flare Traversable LT?	N/A	N/A	Flare Traversable RT?	N/A
N/A	Landing Length (in)	N/A	N/A	DWS Provided?	N/A
N/A	Landing Width (in)	N/A	N/A	DWS Contrast?	N/A
N/A	Landing Slope (%)	N/A	N/A	DWS Length (in)	N/A
N/A	Landing X Slope (%)	N/A	N/A	DWS Full Width?	N/A
N/A	Landing Curb? (Y/N)	N/A	N/A	DWS Offset (in)	N/A
N/A	Shared Landing?	N/A			
N/A	Gutter Ponding?	N/A	N/A	Gutter Slope (%)	N/A
N/A	Gutter Lip Ht (in)	N/A	N/A	Gutter X Slope (%)	N/A
N/A	Painted X Walk1?	No	N/A	Painted X Walk2?	No

X Walk 1 Direction	To NE		X Walk 2 Direction	To NW
	X Walk 1 Width (in)	N/A		X Walk 2 Width (in)	N/A
	X Walk 1 Slope (%)	3.4		X Walk 2 Slope (%)	3.8
	X Walk 1 X Slope (%)	3.6		X Walk 2 X Slope (%)	1.2
N/A	Ramp inside XWalk1?	N/A	N/A	Ramp inside XWalk2?	N/A
	Road Slope (%)	0.5		Clear Space?	N/A
	Road X Slope (%)	3.5	N/A	Clear Space to XWalk (in)	N/A
			N/A	Any Obstruction?	N/A
				Obstruction Type	N/A
			N/A	Storm Grate/Utility Hazard?	N/A
				Storm Grate/Utility Type	N/A
			Yes	Surface Condition? (G/P)	Good
				Curb Slope (%)	11.2

Remove & Replace Curb Ramp With Two New Directional Ramps or Equivalent.
