## **Access Compliance Report Public Rights-of-Way** (Curb Ramps)

Intersection ID: 20612 Main Street: ARTWOOD\_LN Cross Street: WOODKNOLL\_DR Location: **Overall Compliance: No** Severity Score: 31.25 ADA ID: 3B65A69DFD9C Ramp Type: Perp Initial Pass/Fail: Fail

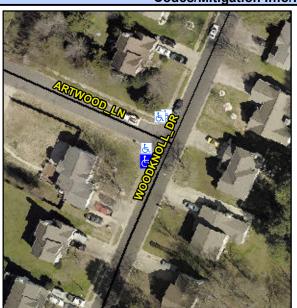
Field Measurements/Component Compliance							
Comp	liance Description	Data	Comp	liance	Description	Data	
N/A	Ramp Length (in)	91.0	No	Ramp	Slope (%)	9.1	
No	Ramp Width (in)	34.0	No	Ramp	XSlope (%)	3.8	
N/A	Flare Type LT	N/A	N/A	N/A Flare Type RT		N/A	
N/A	Flare Slope LT (%)	N/A	N/A Flare Slope RT (%)		N/A		
N/A	Flare Traversable LT?	N/A	N/A Flare Traversable RT?		N/A		
N/A	Landing Length (in)	N/A	N/A	DWS	Provided?	N/A	
N/A	Landing Width (in)	N/A	N/A	DWS	Contrast?	N/A	
N/A	Landing Slope (%)	N/A	N/A	DWS	Length (in)	N/A	
N/A	Landing X Slope (%)	N/A	N/A	DWS	Full Width?	N/A	
N/A	Landing Curb? (Y/N)	N/A	N/A	DWS	Offset (in)	N/A	
N/A	Shared Landing?	N/A					
N/A	Gutter Ponding?	N/A	N/A	Gutte	r Slope (%)	N/A	
N/A	Gutter Lip Ht (in)	N/A	N/A	Gutte	r X Slope (%)	N/A	
N/A	Painted X Walk1?	No	N/A	Paint	ed X Walk2?	N/A	
	X Walk 1 Direction	To SE		X Wa	lk 2 Direction	N/A	
N/A	X Walk 1 Width (in)	N/A	N/A	X Wa	lk 2 Width (in)	N/A

X Walk 1 Slope (%)	2.2		X Wa	lk 2 Slope (%)	N/A	
	X Walk 1 X Slope (%)	0.3		X Wa	lk 2 X Slope (%)	N/A	
N/A	Ramp inside XWalk1?	N/A	N/A	Ramp	inside XWalk2?	N/A	
	Road Slope (%)	N/A	N/A	Clear	Space?	N/A	
	Road X Slope (%)	N/A	N/A	Clear	Space to XWalk (in)	N/A	
N/A	Any Obstructions?	N/A	N/A	Storm	Grate/Utility Hazard?	N/A	
	Obstruction Type			Storm	Grate/Utility Type		
		N/A				N/A	
			Yes	Surfa	ce Condition? (G/P)	Good

ossible Solutions:	<u>c</u>
Remove & Replace Entire Ramp.	
·	N
	N
	N
	N
	N
urveyor Notes:	N
N/A	N
	N
	N
	N
ROW/ADA:	N
R304.5.1, R304.2.2, R304.5.3	N
,	N
	_
	N
