# Access Compliance Report Public Rights-of-Way (Curb Ramps)

Intersection ID: 14530      Main Street: E\_5TH\_ST      Cross Street: N\_LAUREL\_AV      Location: S

ADA ID: 3B68D70C64C1      Ramp Type: Perp      Initial Pass/Fail: Fail      Overall Compliance: No      Severity Score: 12.5

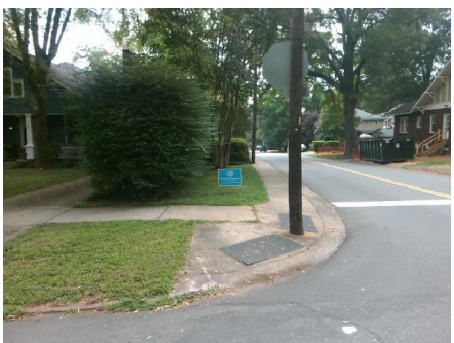
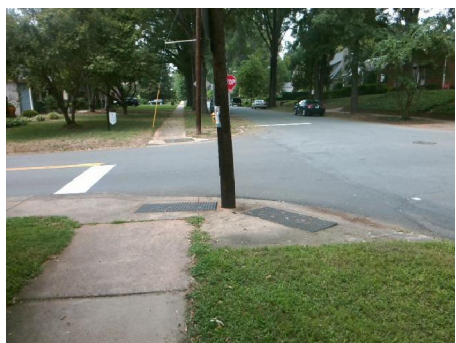
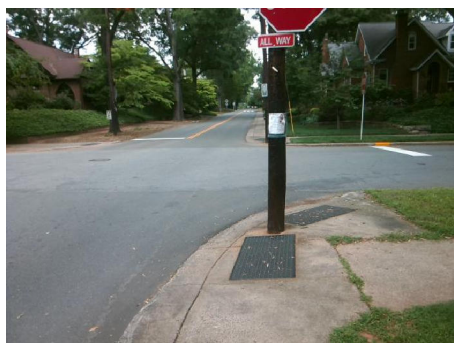
Compliance	Description	Data	Compliance	Description	Data
N/A	Ramp Length (in)	53.0	No	Ramp Slope (%)	9.0
Yes	Ramp Width (in)	48.0	Yes	Ramp XSlope (%)	0.1
N/A	Flare Type LT	N/A	N/A	Flare Type RT	N/A
N/A	Flare Slope LT (%)	N/A	N/A	Flare Slope RT (%)	N/A
N/A	Flare Traversable LT?	N/A	N/A	Flare Traversable RT?	N/A
N/A	Landing Length (in)	N/A	N/A	DWS Provided?	N/A
N/A	Landing Width (in)	N/A	N/A	DWS Contrast?	N/A
N/A	Landing Slope (%)	N/A	N/A	DWS Length (in)	N/A
N/A	Landing X Slope (%)	N/A	N/A	DWS Full Width?	N/A
N/A	Landing Curb? (Y/N)	N/A	N/A	DWS Offset (in)	N/A
N/A	Shared Landing?	N/A			
N/A	Gutter Ponding?	N/A	N/A	Gutter Slope (%)	N/A
N/A	Gutter Lip Ht (in)	N/A	N/A	Gutter X Slope (%)	N/A
N/A	Painted X Walk1?	No	N/A	Painted X Walk2?	N/A
	X Walk 1 Direction	To NE		X Walk 2 Direction	N/A
N/A	X Walk 1 Width (in)	N/A	N/A	X Walk 2 Width (in)	N/A
	X Walk 1 Slope (%)	4.1		X Walk 2 Slope (%)	N/A
	X Walk 1 X Slope (%)	3.6		X Walk 2 X Slope (%)	N/A

N/A	Ramp inside XWalk1?	N/A	N/A	Ramp inside XWalk2?	N/A
	Road Slope (%)	N/A	N/A	Clear Space?	N/A
	Road X Slope (%)	N/A	N/A	Clear Space to XWalk (in)	N/A
N/A	Any Obstructions?	N/A	N/A	Storm Grate/Utility Hazard?	N/A
	Obstruction Type			Storm Grate/Utility Type	
			N/A		N/A
			Yes	Surface Condition? (G/P)	Good

Possible Solutions:  
**Remove & Replace Entire Ramp.**
