Access Compliance Report Public Rights-of-Way (Curb Ramps)

Intersection ID: 10027413 Main Street: GOLF LINKS DR N Cross Street: N/A Location: SW Initial Pass/Fail: Fail **Overall Compliance: No Severity Score:** 12.5 **ADA ID: 3B6AF40319FE** Ramp Type: PerpDiag

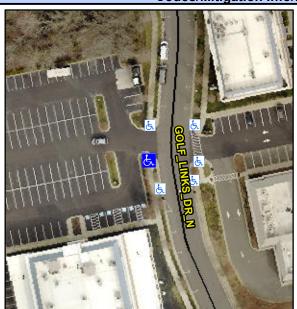
Street 1 Name **GOLF LINKS DR N** Stop Condition-Street 2 StopSign **ENTRANCE** Street 2 Name Stop Condition-Street 1 StopSign Possible Solutions: Remove & Replace Curb Ramp With Two New Directional Ramps or Equivalent. Surveyor Notes: N/A PROW/ADA: Not Found, R304.2.2
