Access Compliance Report Public Rights-of-Way (Curb Ramps)

Intersection ID: 10014556 Main Street: HARRIS_CENTER_DR Cross Street: N/A Location: N

ADA ID: 3B6B7100C4A6 Ramp Type: Combination2 Initial Pass/Fail: Fail Overall Compliance: No Severity Score: 22.5

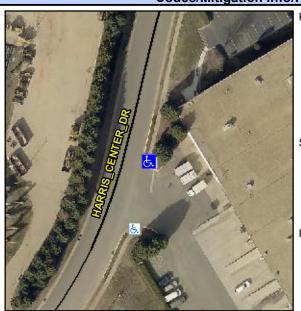
N/A	Ramp Length (in)	34.0	Yes	Ramp Slope (%)	4.7
No	Ramp Width (in)	47.5	No	Ramp XSlope (%)	3.5
N/A	Flare Type LT	N/A	N/A	Flare Type RT	N/A
N/A	Flare Slope LT (%)	N/A	N/A	Flare Slope RT (%)	N/A
N/A	Flare Traversable LT?	N/A	N/A	Flare Traversable RT?	N/A
N/A	Landing Length (in)	N/A	N/A	DWS Provided?	N/A
N/A	Landing Width (in)	N/A	N/A	DWS Contrast?	N/A
N/A	Landing Slope (%)	N/A	N/A	DWS Length (in)	N/A
N/A	Landing X Slope (%)	N/A	N/A	DWS Full Width?	N/A
N/A	Landing Curb? (Y/N)	N/A	N/A	DWS Offset (in)	N/A
N/A	Shared Landing?	N/A			
N/A	Gutter Ponding?	N/A	N/A	Gutter Slope (%)	N/A
N/A	Gutter Lip Ht (in)	N/A	N/A	Gutter X Slope (%)	N/A
N/A	Painted X Walk1?	No	N/A	Painted X Walk2?	N/A
	X Walk 1 Direction	To S		X Walk 2 Direction	N/A
	X Walk 1 Width (in)	N/A		X Walk 2 Width (in)	N/A
	X Walk 1 Slope (%)	0.5		X Walk 2 Slope (%)	N/A
	X Walk 1 X Slope (%)	2.8		X Walk 2 X Slope (%)	N/A
N/A	Ramp inside XWalk1?	N/A	N/A	Ramp inside XWalk2?	N/A

Possible Solutions:

Remove & Replace Entire Ramp.

R304.5.1, R304.5.1, R304.5.3,
R304.3.2
