## **Access Compliance Report Public Rights-of-Way** (Curb Ramps)

Intersection ID: 3193 Main Street: HIGHCROFT LN Cross Street: STONEYKIRK\_LN Location: SE

**Overall Compliance: No** ADA ID: 3B70630BD2C9 Ramp Type: Perp Initial Pass/Fail: Pass Severity Score: 17.75

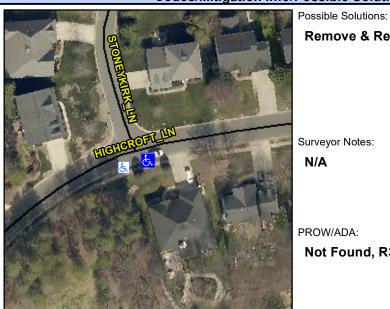
Flare Type LT	Sloped	N/A	Flare Type RT	N/A
Flare Slope LT (%)	2.1	N/A	/A Flare Slope RT (%)	
Flare Traversable LT?	No	N/A	Flare Traversable RT?	No
Landing Length (in)	48.0	No	DWS Provided?	No
Landing Width (in)	48.0	N/A	DWS Contrast?	No
Landing Slope (%)	1.3	N/A	DWS Length (in)	N/A
Landing X Slope (%)	1.4	N/A	I/A DWS Full Width?	
Landing Curb? (Y/N)	No	N/A	I/A DWS Offset (in)	
Shared Landing?	No			
Gutter Ponding?	No	Yes	Gutter Slope (%)	1.1
Gutter Lip Ht (in)	0.5	Yes	Gutter X Slope (%)	2.9
Painted X Walk1?	No	N/A	Painted X Walk2?	N/A
X Walk 1 Direction	To N		X Walk 2 Direction	N/A
X Walk 1 Width (in)	N/A	N/A	X Walk 2 Width (in)	N/A
X Walk 1 Slope (%)	5.0		X Walk 2 Slope (%)	N/A
X Walk 1 X Slope (%)	3.8		X Walk 2 X Slope (%)	N/A
Ramp inside XWalk1?	N/A	N/A	Ramp inside XWalk2?	N/A
Road Slope (%)	N/A	N/A	Clear Space?	Yes
Road X Slope (%)	N/A	N/A	Clear Space to XWalk (in)	N/A
Any Obstructions?	No	Yes	Storm Grate/Utility Hazard?	No

Remove & Replace Entire Ramp.	
Surveyor Notes:	
PROW/ADA: Not Found, R304.5.3, R305, R302.7.2
