## **Access Compliance Report Public Rights-of-Way** (Curb Ramps)

Main Street: LINDA VISTA LN Intersection ID: 4965 **Cross Street: TRULL ST** Location: SW Initial Pass/Fail: Fail **Overall Compliance: No Severity Score:** 25 ADA ID: 3B8072725693 Ramp Type: BlendTrans1

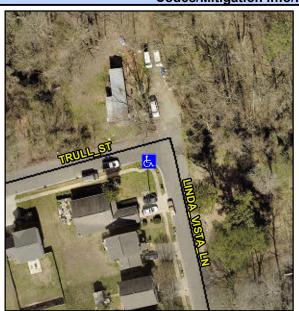
Compliance Description Data Compliance Description Data Yes N/A Ramp Length (in) 46.5 BlendTrans Slope (%) 0.4 48.0 No Yes Ramp Width (in) BlendTrans XSlope (%) 7.4 N/A N/A Flare Type LT N/A Flare Type RT N/A N/A Flare Slope LT (%) N/A N/A Flare Slope RT (%) N/A N/A Flare Traversable LT? N/A N/A Flare Traversable RT? N/A N/A Landing Length (in) N/A N/A **DWS Provided?** N/A N/A Landing Width (in) N/A N/A **DWS Contrast?** N/A N/A N/A N/A Landing Slope (%) DWS Length (in) N/A N/A Landing X Slope (%) N/A N/A DWS Full Width? N/A N/A Landing Curb? (Y/N) N/A N/A DWS Offset (in) N/A N/A N/A Shared Landing? N/A **Gutter Ponding?** N/A N/A Gutter Slope (%) N/A N/A Gutter Lip Ht (in) N/A N/A Gutter X Slope (%) N/A N/A Painted X Walk1? No N/A Painted X Walk2? No X Walk 1 Direction To E X Walk 2 Direction To N N/A X Walk 1 Width (in) X Walk 2 Width (in) N/A X Walk 1 Slope (%) 7.2 X Walk 2 Slope (%) N/A X Walk 1 X Slope (%) 5.8 X Walk 2 X Slope (%) N/A N/A N/A Ramp inside XWalk2? N/A Ramp inside XWalk1? N/A Road Slope (%) 5.8 Clear Space? N/A Road X Slope (%) 7.2 N/A Clear Space to XWalk (in) N/A N/A N/A N/A Any Obstructions? Storm Grate/Utility Hazard? N/A **Obstruction Type** Storm Grate/Utility Type N/A N/A Surface Condition? (G/P) Good Yes N/A Curb Slope (%) 2.9

**LINDA VISTA LN** Street 1 Name Stop Condition-Street 1 **TRULL ST** Street 2 Name Stop Condition-Street 2 StopSign Possible Solutions: Remove & Replace Curb Ramp With Two New Directional Ramps or Equivalent. Surveyor Notes: N/A PROW/ADA: R304.5.3
