Access Compliance Report

Public Rights-of-Way

(Curb Ramps)

Intersection ID: 26310	Main Street: BEVINGTON_PL	Cross Street: BEVINGTON_RIDGE_RD	Location: S
ADA ID: 3B882EBB3777	Ramp Type: BlendTrans1	Initial Pass/Fail: Fail	Overall Compliance: No
		Severity Score: 10

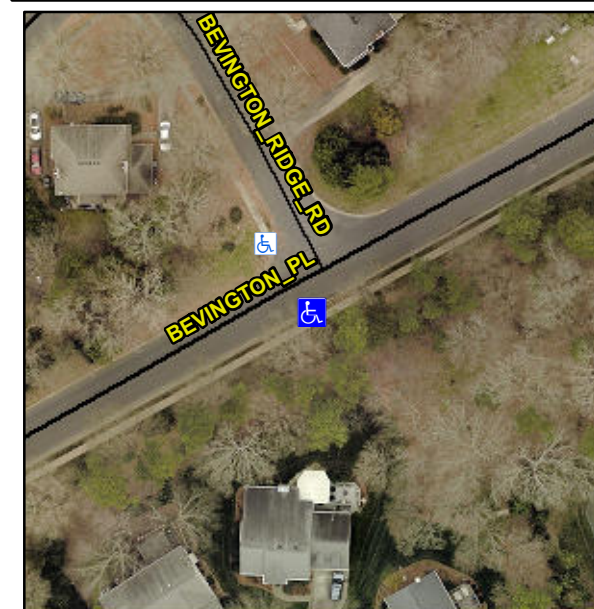
Not Found, R304.5.1, R304.5.3

Compliance	Description	Data	Compliance	Description	Data
N/A	Ramp Length (in)	34.0	Yes	BlendTrans Slope (%)	3.9
No	Ramp Width (in)	46.0	No	BlendTrans XSlope (%)	4.6
N/A	Flare Type LT	N/A	N/A	Flare Type RT	N/A
N/A	Flare Slope LT (%)	N/A	N/A	Flare Slope RT (%)	N/A
N/A	Flare Traversable LT?	N/A	N/A	Flare Traversable RT?	N/A
N/A	Landing Length (in)	N/A	N/A	DWS Provided?	N/A
N/A	Landing Width (in)	N/A	N/A	DWS Contrast?	N/A
N/A	Landing Slope (%)	N/A	N/A	DWS Length (in)	N/A
N/A	Landing X Slope (%)	N/A	N/A	DWS Full Width?	N/A
N/A	Landing Curb? (Y/N)	N/A	N/A	DWS Offset (in)	N/A
N/A	Shared Landing?	N/A			
N/A	Gutter Ponding?	N/A	N/A	Gutter Slope (%)	N/A
N/A	Gutter Lip Ht (in)	N/A	N/A	Gutter X Slope (%)	N/A
N/A	Painted X Walk1?	No	N/A	Painted X Walk2?	N/A
	X Walk 1 Direction	To NW		X Walk 2 Direction	N/A
	X Walk 1 Width (in)	N/A		X Walk 2 Width (in)	N/A
	X Walk 1 Slope (%)	4.6		X Walk 2 Slope (%)	N/A
	X Walk 1 X Slope (%)	2.7		X Walk 2 X Slope (%)	N/A

N/A	Ramp inside XWalk1?	N/A	N/A	Ramp inside XWalk2?	N/A
	Road Slope (%)	2.7		Clear Space?	N/A
	Road X Slope (%)	4.6	N/A	Clear Space to XWalk (in)	N/A
N/A	Any Obstructions?	N/A	N/A	Storm Grate/Utility Hazard?	N/A
	Obstruction Type			Storm Grate/Utility Type	
		N/A			N/A
			Yes	Surface Condition? (G/P)	Good
			No	Curb Slope (%)	8.7

Remove & Replace Curb Ramp With Two New Directional Ramps or Equivalent.
