# Access Compliance Report

## Public Rights-of-Way

### (Curb Ramps)

Intersection ID: 13568	Main Street: ARLINGTON_AV	Cross Street: SOUTH_BV	Location: SE
ADA ID: 3B88711A0844	Ramp Type: PerpDiag	Initial Pass/Fail: Fail	Overall Compliance: No
Codes/Mitigation Info/Possible Solution		Field Measurements/Component Compliance	
Severity Score: 21.25

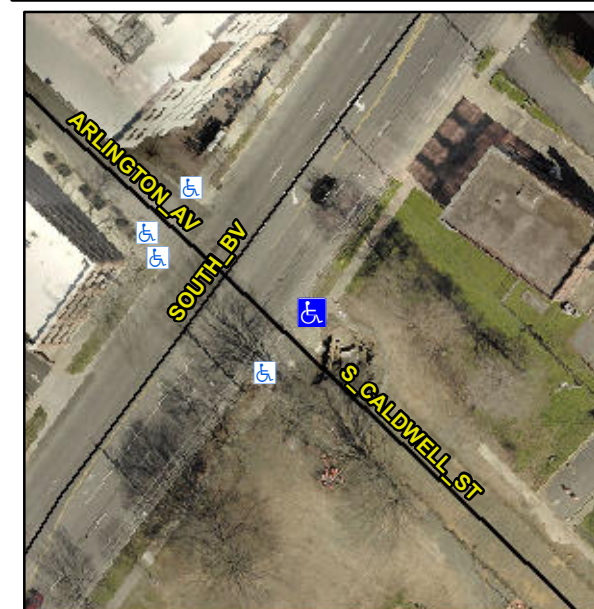
Compliance	Description	Data	Compliance	Description	Data
N/A	Ramp Length (in)	60.0	Yes	Ramp Slope (%)	6.6
No	Ramp Width (in)	42.0	No	Ramp XSlope (%)	5.4
N/A	Flare Type LT	N/A	N/A	Flare Type RT	N/A
N/A	Flare Slope LT (%)	N/A	N/A	Flare Slope RT (%)	N/A
N/A	Flare Traversable LT?	N/A	N/A	Flare Traversable RT?	N/A
N/A	Landing Length (in)	N/A	N/A	DWS Provided?	N/A
N/A	Landing Width (in)	N/A	N/A	DWS Contrast?	N/A
N/A	Landing Slope (%)	N/A	N/A	DWS Length (in)	N/A
N/A	Landing X Slope (%)	N/A	N/A	DWS Full Width?	N/A
N/A	Landing Curb? (Y/N)	N/A	N/A	DWS Offset (in)	N/A
N/A	Shared Landing?	N/A			
N/A	Gutter Ponding?	N/A	N/A	Gutter Slope (%)	N/A
N/A	Gutter Lip Ht (in)	1.0	N/A	Gutter X Slope (%)	N/A
N/A	Painted X Walk1?	No	N/A	Painted X Walk2?	Yes
	X Walk 1 Direction	To NW		X Walk 2 Direction	To SW
N/A	X Walk 1 Width (in)	N/A	N/A	X Walk 2 Width (in)	118.0
	X Walk 1 Slope (%)	3.8		X Walk 2 Slope (%)	1.4
	X Walk 1 X Slope (%)	3.1		X Walk 2 X Slope (%)	6.8

N/A	Ramp inside XWalk1?	N/A	N/A	Ramp inside XWalk2?	Yes
	Road Slope (%)	3.9	N/A	Clear Space?	N/A
	Road X Slope (%)	3.5	N/A	Clear Space to XWalk (in)	N/A
N/A	Any Obstructions?	N/A	N/A	Storm Grate/Utility Hazard?	N/A
	Obstruction Type			Storm Grate/Utility Type	
		N/A			N/A
			Yes	Surface Condition? (G/P)	Good

Possible Solutions:

**Remove & Replace Curb Ramp With Two New Directional Ramps or Equivalent.**

**R304.5.1, R304.5.3**

Total Cost: \$ 3200.00
