Access Compliance Report

Public Rights-of-Way

(Curb Ramps)

Intersection ID: 11446	Main Street: GRACE_ST	Cross Street: PEGRAM_ST	Location: SW
ADA ID: 3B8CE7DF8E35	Ramp Type: BlendTrans2	Initial Pass/Fail: Fail	Overall Compliance: No
		Severity Score: 10

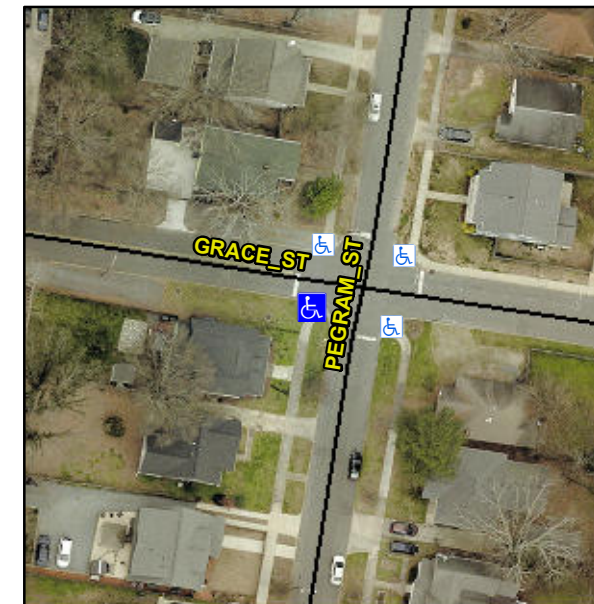
Not Found, R304.5.1, R304.5.3

Compliance	Description	Data	Compliance	Description	Data
N/A	Ramp Length (in)	61.0	Yes	BlendTrans Slope (%)	3.2
No	Ramp Width (in)	47.5	No	BlendTrans XSlope (%)	3.0
N/A	Flare Type LT	N/A	N/A	Flare Type RT	N/A
N/A	Flare Slope LT (%)	N/A	N/A	Flare Slope RT (%)	N/A
N/A	Flare Traversable LT?	N/A	N/A	Flare Traversable RT?	N/A
N/A	Landing Length (in)	N/A	N/A	DWS Provided?	N/A
N/A	Landing Width (in)	N/A	N/A	DWS Contrast?	N/A
N/A	Landing Slope (%)	N/A	N/A	DWS Length (in)	N/A
N/A	Landing X Slope (%)	N/A	N/A	DWS Full Width?	N/A
N/A	Landing Curb? (Y/N)	N/A	N/A	DWS Offset (in)	N/A
N/A	Shared Landing?	N/A			
N/A	Gutter Ponding?	N/A	N/A	Gutter Slope (%)	N/A
N/A	Gutter Lip Ht (in)	1.0	N/A	Gutter X Slope (%)	N/A
N/A	Painted X Walk1?	No	N/A	Painted X Walk2?	No
	X Walk 1 Direction	To E		X Walk 2 Direction	To N
	X Walk 1 Width (in)	N/A		X Walk 2 Width (in)	N/A
	X Walk 1 Slope (%)	0.3		X Walk 2 Slope (%)	4.0
	X Walk 1 X Slope (%)	4.7		X Walk 2 X Slope (%)	0.3

N/A	Ramp inside XWalk1?	N/A	N/A	Ramp inside XWalk2?	N/A
	Road Slope (%)	3.1		Clear Space?	N/A
	Road X Slope (%)	3.9	N/A	Clear Space to XWalk (in)	N/A
N/A	Any Obstructions?	N/A	N/A	Storm Grate/Utility Hazard?	N/A
	Obstruction Type			Storm Grate/Utility Type	
		N/A			N/A
			Yes	Surface Condition? (G/P)	Good
			No	Curb Slope (%)	15.4

Remove & Replace Curb Ramp With Two New Directional Ramps or Equivalent.
