# Access Compliance Report

## Public Rights-of-Way

Intersection ID: 27907	Main Street: BAY_HILL_CLUB_DR	Cross Street: COLONIAL_COUNTRY_LN	Location: NW
ADA ID: 3B907FBC8A51	Ramp Type: BlendTrans1	Initial Pass/Fail: Fail	Overall Compliance: No
		Severity Score: 1.25

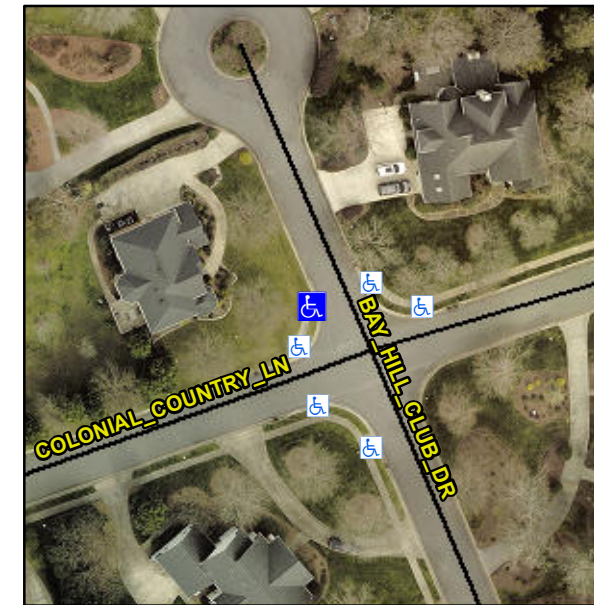
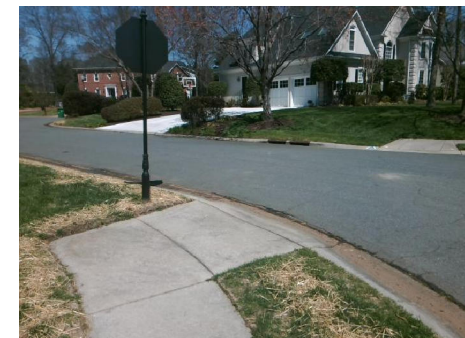
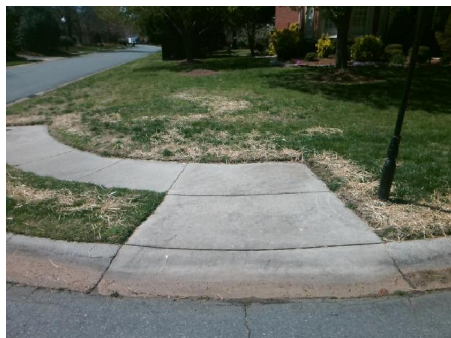
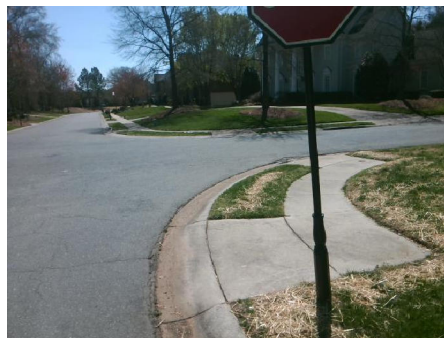
**NO RT SW**

**Not Found, R304.5.3**

Compliance	Description	Data	Compliance	Description	Data
N/A	Ramp Length (in)	47.0	Yes	BlendTrans Slope (%)	2.9
Yes	Ramp Width (in)	91.0	No	BlendTrans XSlope (%)	4.0
N/A	Flare Type LT	N/A	N/A	Flare Type RT	N/A
N/A	Flare Slope LT (%)	N/A	N/A	Flare Slope RT (%)	N/A
N/A	Flare Traversable LT?	N/A	N/A	Flare Traversable RT?	N/A
N/A	Landing Length (in)	N/A	N/A	DWS Provided?	N/A
N/A	Landing Width (in)	N/A	N/A	DWS Contrast?	N/A
N/A	Landing Slope (%)	N/A	N/A	DWS Length (in)	N/A
N/A	Landing X Slope (%)	N/A	N/A	DWS Full Width?	N/A
N/A	Landing Curb? (Y/N)	N/A	N/A	DWS Offset (in)	N/A
N/A	Shared Landing?	N/A			
N/A	Gutter Ponding?	N/A	N/A	Gutter Slope (%)	N/A
N/A	Gutter Lip Ht (in)	N/A	N/A	Gutter X Slope (%)	N/A
N/A	Painted X Walk1?	No	N/A	Painted X Walk2?	N/A
	X Walk 1 Direction	To NE		X Walk 2 Direction	N/A
	X Walk 1 Width (in)	N/A		X Walk 2 Width (in)	N/A
	X Walk 1 Slope (%)	3.4		X Walk 2 Slope (%)	N/A
	X Walk 1 X Slope (%)	2.1		X Walk 2 X Slope (%)	N/A

N/A	Ramp inside XWalk1?	N/A	N/A	Ramp inside XWalk2?	N/A
	Road Slope (%)	2.1		Clear Space?	N/A
	Road X Slope (%)	3.4	N/A	Clear Space to XWalk (in)	N/A
N/A	Any Obstructions?	N/A	N/A	Storm Grate/Utility Hazard?	N/A
	Obstruction Type			Storm Grate/Utility Type	
		N/A			N/A
			Yes	Surface Condition? (G/P)	Good
			No	Curb Slope (%)	9.2

**Remove & Replace Curb Ramp With Two New Directional Ramps or Equivalent.**
