Access Compliance Report

Public Rights-of-Way

(Curb Ramps)

Intersection ID: 3676	Main Street: DENALI_LN	Cross Street: RIVA_RIDGE_CT	Location: NW
ADA ID: 3B96360896E4	Ramp Type: Perp	Initial Pass/Fail: Fail	Overall Compliance: No
Severity Score: 25			
Codes/Mitigation Info/Possible Solution		Field Measurements/Component Compliance

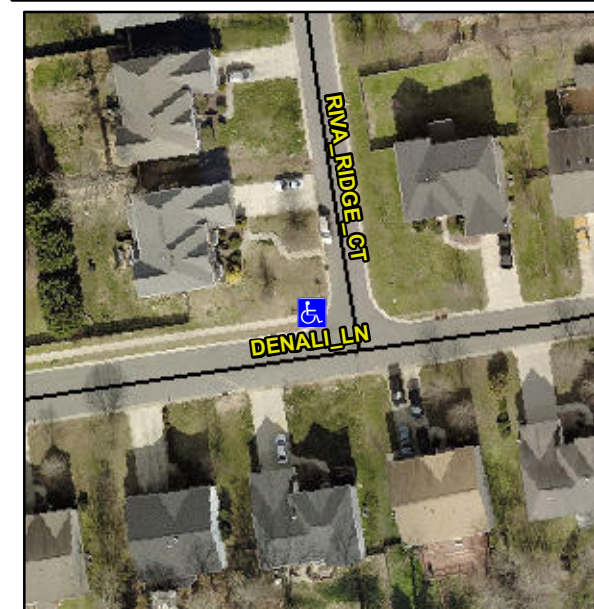
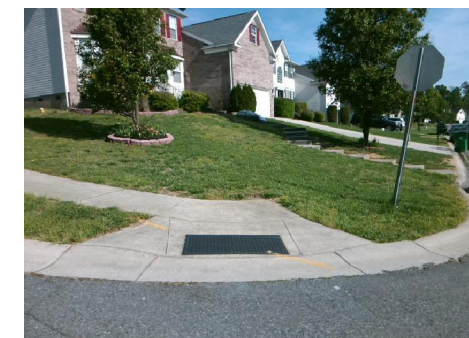
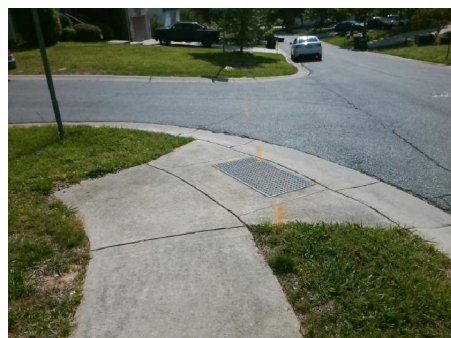
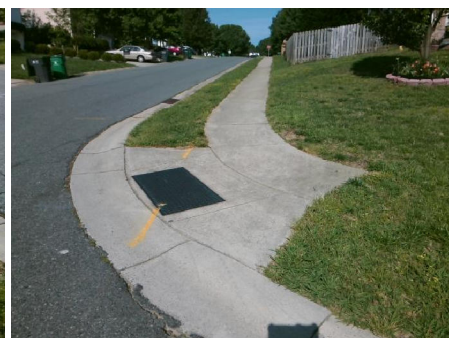
Not Found, R304.5.3

Compliance	Description	Data	Compliance	Description	Data
N/A	Ramp Length (in)	48.0	Yes	Ramp Slope (%)	6.1
Yes	Ramp Width (in)	48.0	No	Ramp XSlope (%)	8.6
N/A	Flare Type LT	N/A	N/A	Flare Type RT	N/A
N/A	Flare Slope LT (%)	N/A	N/A	Flare Slope RT (%)	N/A
N/A	Flare Traversable LT?	N/A	N/A	Flare Traversable RT?	N/A
N/A	Landing Length (in)	N/A	N/A	DWS Provided?	N/A
N/A	Landing Width (in)	N/A	N/A	DWS Contrast?	N/A
N/A	Landing Slope (%)	N/A	N/A	DWS Length (in)	N/A
N/A	Landing X Slope (%)	N/A	N/A	DWS Full Width?	N/A
N/A	Landing Curb? (Y/N)	N/A	N/A	DWS Offset (in)	N/A
N/A	Shared Landing?	N/A			
N/A	Gutter Ponding?	N/A	N/A	Gutter Slope (%)	N/A
N/A	Gutter Lip Ht (in)	N/A	N/A	Gutter X Slope (%)	N/A
N/A	Painted X Walk1?	No	N/A	Painted X Walk2?	N/A
	X Walk 1 Direction	To E		X Walk 2 Direction	N/A
N/A	X Walk 1 Width (in)	N/A	N/A	X Walk 2 Width (in)	N/A
	X Walk 1 Slope (%)	3.5		X Walk 2 Slope (%)	N/A
	X Walk 1 X Slope (%)	8.0		X Walk 2 X Slope (%)	N/A

N/A	Ramp inside XWalk1?	N/A	N/A	Ramp inside XWalk2?	N/A
	Road Slope (%)	8.0	N/A	Clear Space?	N/A
	Road X Slope (%)	3.5	N/A	Clear Space to XWalk (in)	N/A
N/A	Any Obstructions?	N/A	N/A	Storm Grate/Utility Hazard?	N/A
	Obstruction Type			Storm Grate/Utility Type	
		N/A			N/A
			Yes	Surface Condition? (G/P)	Good

Possible Solutions:

Remove & Replace Entire Ramp.
