Access Compliance Report

Public Rights-of-Way

(Curb Ramps)

Intersection ID: 9610	Main Street: BARRINGTON_DR	Cross Street: THE_PLAZA	Location: W
ADA ID: 3BA9FB4C314B	Ramp Type: PerpDiag	Initial Pass/Fail: Fail	Overall Compliance: No
Severity Score: 12.5			
Codes/Mitigation Info/Possible Solution		Field Measurements/Component Compliance

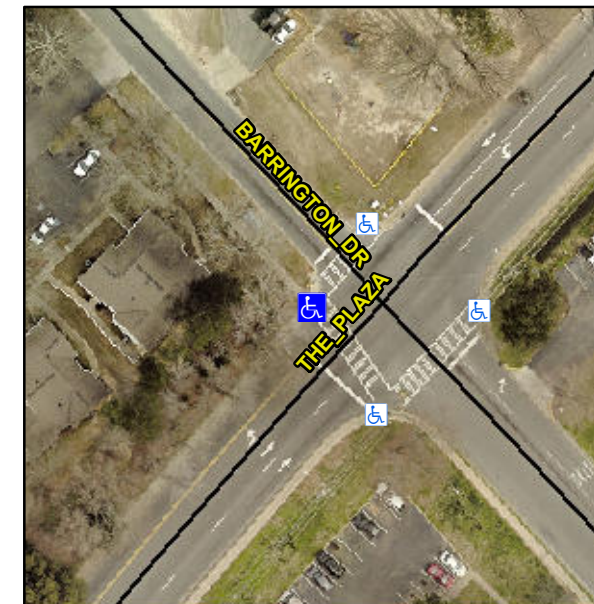
Not Found, R304.2.2

Compliance	Description	Data	Compliance	Description	Data
N/A	Ramp Length (in)	48.0	No	Ramp Slope (%)	10.9
Yes	Ramp Width (in)	48.0	Yes	Ramp XSlope (%)	1.1
N/A	Flare Type LT	N/A	N/A	Flare Type RT	N/A
N/A	Flare Slope LT (%)	N/A	N/A	Flare Slope RT (%)	N/A
N/A	Flare Traversable LT?	N/A	N/A	Flare Traversable RT?	N/A
N/A	Landing Length (in)	N/A	N/A	DWS Provided?	N/A
N/A	Landing Width (in)	N/A	N/A	DWS Contrast?	N/A
N/A	Landing Slope (%)	N/A	N/A	DWS Length (in)	N/A
N/A	Landing X Slope (%)	N/A	N/A	DWS Full Width?	N/A
N/A	Landing Curb? (Y/N)	N/A	N/A	DWS Offset (in)	N/A
N/A	Shared Landing?	N/A			
N/A	Gutter Ponding?	N/A	N/A	Gutter Slope (%)	N/A
N/A	Gutter Lip Ht (in)	N/A	N/A	Gutter X Slope (%)	N/A
N/A	Painted X Walk1?	Yes	N/A	Painted X Walk2?	Yes
	X Walk 1 Direction	To SE		X Walk 2 Direction	To NE
N/A	X Walk 1 Width (in)	114.0	N/A	X Walk 2 Width (in)	109.5
	X Walk 1 Slope (%)	0.8		X Walk 2 Slope (%)	4.0
	X Walk 1 X Slope (%)	2.4		X Walk 2 X Slope (%)	0.7

N/A	Ramp inside XWalk1?	Yes	N/A	Ramp inside XWalk2?	Yes
	Road Slope (%)	0.7	N/A	Clear Space?	N/A
	Road X Slope (%)	4.5	N/A	Clear Space to XWalk (in)	N/A
N/A	Any Obstructions?	N/A	N/A	Storm Grate/Utility Hazard?	N/A
	Obstruction Type			Storm Grate/Utility Type	
		N/A			N/A
		Yes		Surface Condition? (G/P)	Good

Remove & Replace Curb Ramp With Two New Directional Ramps or Equivalent.

Total Cost: \$ 3200.00
