Access Compliance Report

Public Rights-of-Way

(Curb Ramps)

Intersection ID: 10023486	Main Street: CIRCUMFERENTIAL_RD	Cross Street: N/A	Location: SE
ADA ID: 3BAFADE1E181	Ramp Type: Perp	Initial Pass/Fail: Pass	Overall Compliance: No
Codes/Mitigation Info/Possible Solution		Field Measurements/Component Compliance	
Severity Score: 2.5

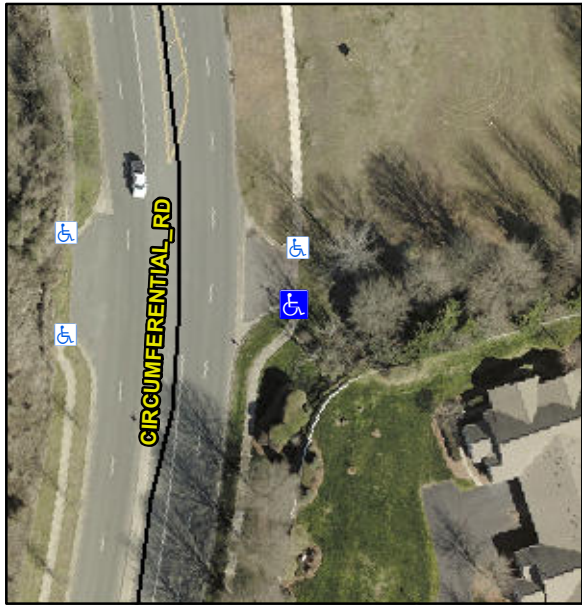
Possible Solutions:		Compliance		Description	Data	Compliance		Description	Data
	Remove & Replace Entire Ramp.		N/A	Ramp Length (in)	28.0	Yes	Ramp Slope (%)	6.2		
	Remove & Replace Gutter.		Yes	Ramp Width (in)	48.0	Yes	Ramp XSlope (%)	0.0		
			N/A	Flare Type LT	None	N/A	Flare Type RT	N/A		
			N/A	Flare Slope LT (%)	N/A	N/A	Flare Slope RT (%)	N/A		
			N/A	Flare Traversable LT?	N/A	N/A	Flare Traversable RT?	N/A		
			Yes	Landing Length (in)	53.0	Yes	DWS Provided?	Yes		
			Yes	Landing Width (in)	48.0	Yes	DWS Contrast?	Yes		
			Yes	Landing Slope (%)	2.0	Yes	DWS Length (in)	24.0		
			No	Landing X Slope (%)	2.4	No	DWS Full Width?	No		
Surveyor Notes: N/A PROW/ADA: R304.5.3, R305.1.4			N/A	Landing Curb? (Y/N)	No	Yes	DWS Offset (in)	1.5		
			N/A	Shared Landing?	No					
			Yes	Gutter Ponding?	No	Yes	Gutter Slope (%)	3.5		
			Yes	Gutter Lip Ht (in)	0.0	No	Gutter X Slope (%)	2.8		
			N/A	Painted X Walk1?	No	N/A	Painted X Walk2?	N/A

X Walk 1 Direction	To N		X Walk 2 Direction	N/A		
			N/A	X Walk 1 Width (in)	N/A	N/A	X Walk 2 Width (in)	N/A		
				X Walk 1 Slope (%)	5.0		X Walk 2 Slope (%)	N/A		
				X Walk 1 X Slope (%)	0.3		X Walk 2 X Slope (%)	N/A		
			N/A	Ramp inside XWalk1?	N/A	N/A	Ramp inside XWalk2?	N/A		
Street 1 Name ENTRANCE Stop Condition-Street 2 None Street 2 Name N/A Stop Condition-Street 1 N/A				Road Slope (%)	N/A	N/A	Clear Space?	Yes		
				Road X Slope (%)	N/A	N/A	Clear Space to XWalk (in)	N/A		
			Yes	Any Obstructions?	No	Yes	Storm Grate/Utility Hazard?	No		
				Obstruction Type			Storm Grate/Utility Type			
						N/A		N/A		
						Yes	Surface Condition? (G/P)	Good		
Total Cost:		\$	2600.00
